Article

Integrated Testing of Building Fabric Thermal Performance for Calibration of Energy Models of Three Low-Energy Dwellings in the UK

Abstract: This paper presents the methodology and results of in situ testing of building fabric thermal performance to calibrate as-built energy models of three low-energy dwellings in the UK, so as to examine the gap between as-designed and as-built energy performance. The in situ tests included repeat testing of air permeability (AP) integrated with thermal imaging survey and heat flux measurements of the building fabric elements, along with concurrent monitoring of indoor temperature during the pre-occupancy stage. Despite being designed to high thermal standards, wall and roof U-values were measured to be higher than expected. Thermal imaging surveys revealed air leakage pathways around door/window openings, penetrations and junctions between walls and ceilings, indicating poor detailing and workmanship. AP was found to have increased after the initial test due to post-completion alteration to the building fabric. Though the results did not meet design expectation, they were within the UK Building Regulations. Calibration of energy models

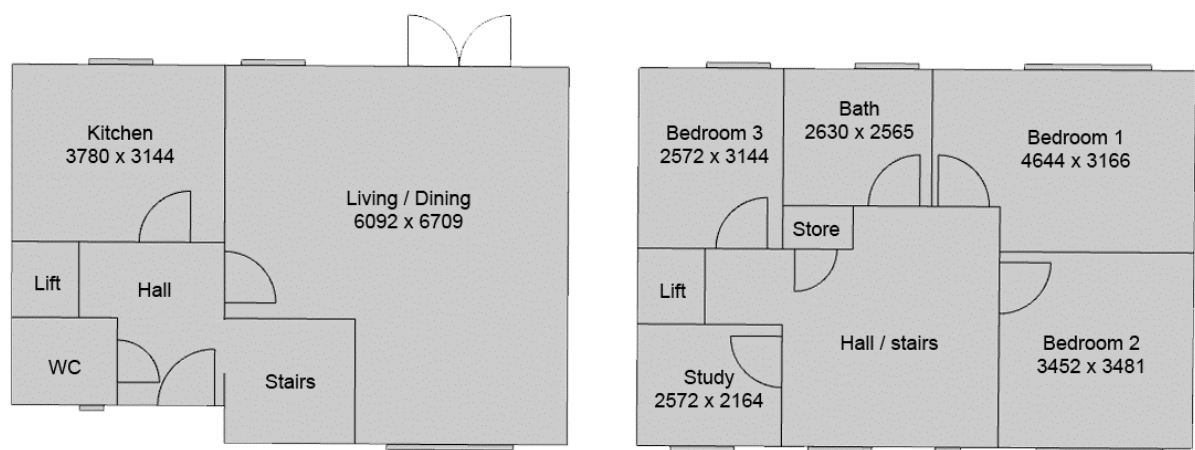
Figure 3. Basic layout of model C4.

For modelling purposes ZP1 and ZP2 are a single model (semi-detached type), i.e., type 'B3' (Figure 2) and ZP3 is a model of the detached type, 'C4' (Figure 3). ZP1 and ZP2 have a common energy model in the design stage since the only physical difference was the mirroring of the plan along the party wall. Furthermore, the Standard Assessment Procedure (SAP) model used the same building fabric, energy system, and occupancy inputs for both dwellings leading to same outputs in terms of energy consumption. Finally, as will be seen later, single heat flux measurements were taken to represent wall and roof thermal transmittance in both dwellings. The difference in measured air permeability results between the two dwellings is also negligible. The as-designed energy models used the U-values and AP values listed in Table 2 above. Occupancy for the B3 model included two adults and one child; for C4 this was two adults and two children. In all models, the set point for the living room was set at 21 and 19 °C for all other rooms. The daily heating pattern for all dwellings was set for 06:00–10:00 and 18:00–23:00. Hourly weather data are typical meteorological year data (TMY) for Leeds, England located 38 km from the site. Table 4 shows more detail on how the models were constructed.

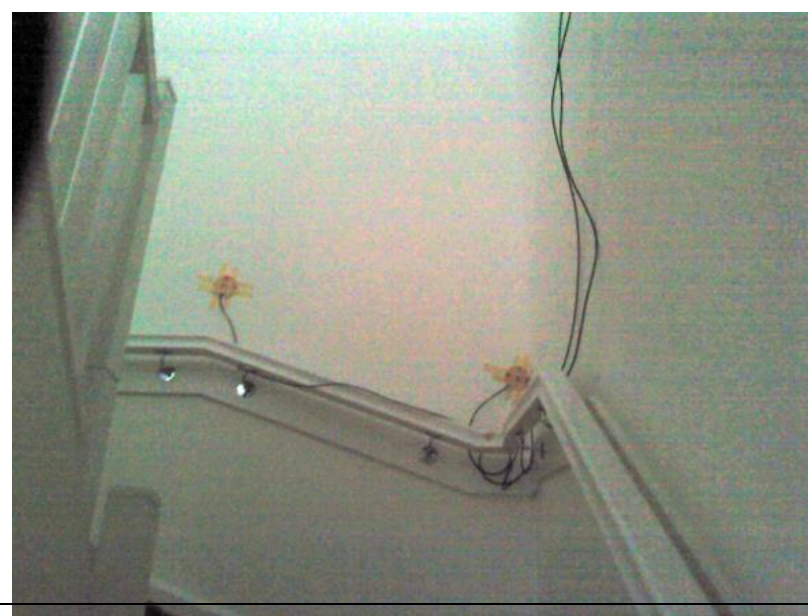
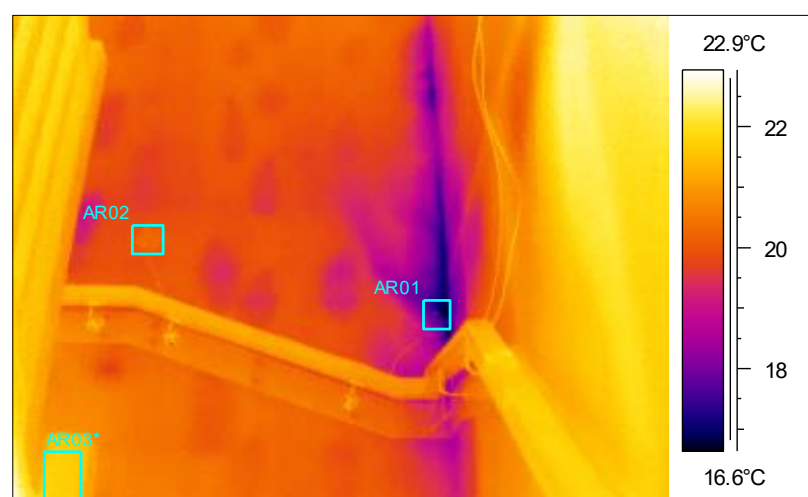
Figure 4. ZP1 heat flux measurement location on stairway wall (a) with thermal image (b).

The locations were first selected by preferring northerly orientation, avoiding facades exposed to solar radiation and avoiding heat sources. Paired heat flux plates were used to observe the difference between what was observed to be ‘good’ and ‘poor’ areas of building fabric as assessed through the thermal imaging assessment. For each surface area selected for heat flux measurement, the ‘good’ refers to the warmer surface temperature that covers most of the surface as seen through thermal imaging (Figure 4). ‘Poor’ refers to areas that stand out with notably lower surface temperatures. These are areas of thermal bypass and the results of expected thermal bridges. In ZP1 the surface temperature difference between good and poor areas on the thermal image were 3 °C during depressurisation. In ZP3, the difference was 2.9 °C. The aim was to measure between the largest surface temperature difference (approximately 3 °C) between the ‘good’, majority of wall and ‘poor’, anomaly location of wall area as reported through thermal imaging assessment. Figure 2 shows the heat flux measurement location on stairway wall in ZP1 as dictated by thermography. AR02 is the “good” spot and AR01 is the “poor” spot.

difference was 2.9 °C. The aim was to measure between the largest surface temperature difference (approximately 3 °C) between the ‘good’, majority of wall and ‘poor’, anomaly location of wall area as reported through thermal imaging assessment. Figure 2 shows the heat flux measurement location on stairway wall in ZP1 as dictated by thermography. AR02 is the “good” spot and AR01 is the “poor” spot.

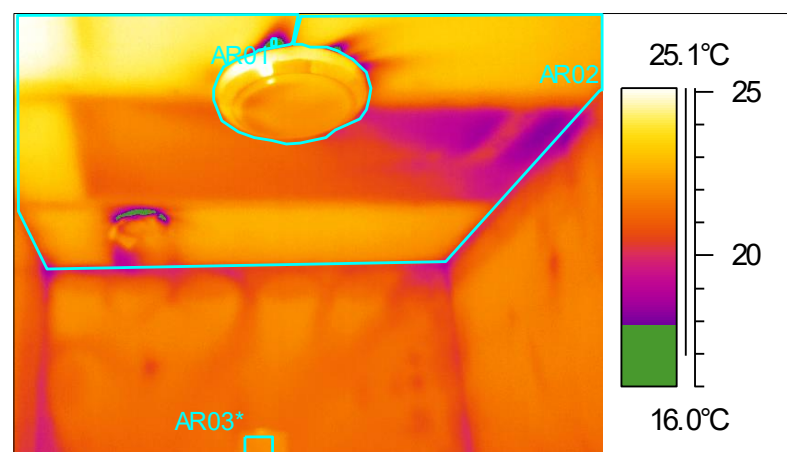
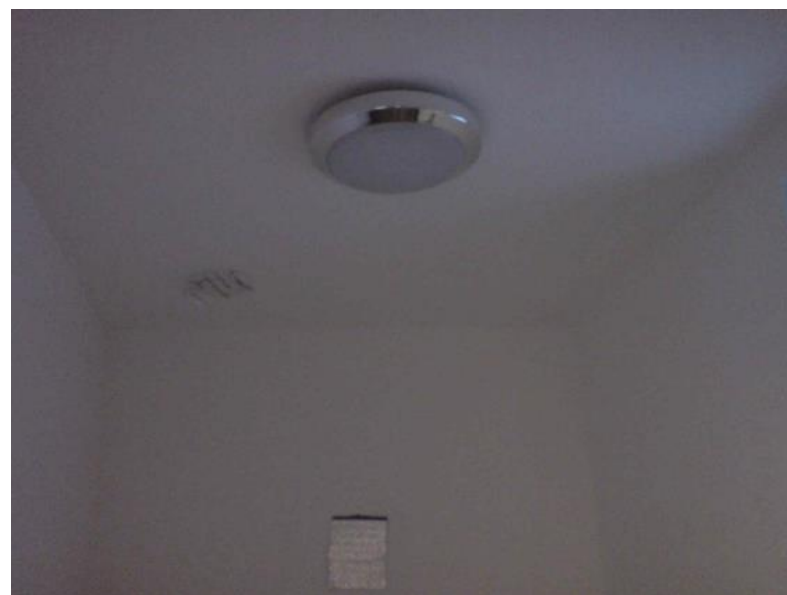
Figure 8. Bulkhead light within the WC of ZP1 during depressurisation. (a) thermal image, (b) photograph of thermal image location.

During depressurisation air leakage was also identified emanating around fixed units on the ceiling and walls, an example of this can be seen in Figure 8. This is an image of the bulkhead light within the WC which did not show signs of air leakage until depressurisation. In this image, the TI is 0.72 under depressurisation but 0.79 before depressurisation. Both before and during depressurisation, possible missing or displaced insulation is also notable in the ceiling; however, the anomaly does not pose a high risk for condensation.

units on the ceiling and walls, an example of this can be seen in Figure 8. This is an image of the bulkhead light within the WC which did not show signs of air leakage until depressurisation. In this image, the TI is 0.72 under depressurisation but 0.79 before depressurisation. Both before and during depressurisation, possible missing or displaced insulation is also notable in the ceiling; however, the anomaly does not pose a high risk for condensation.

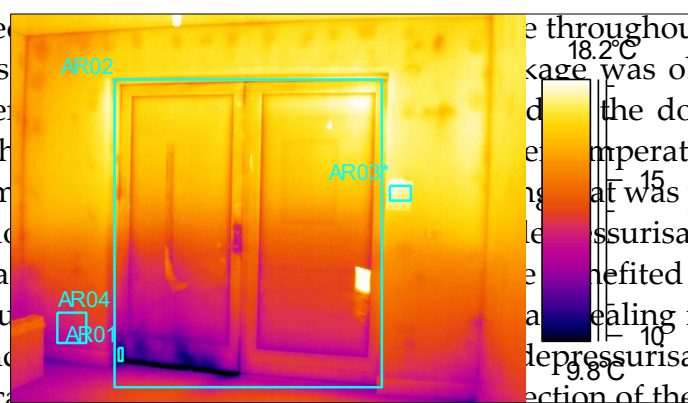
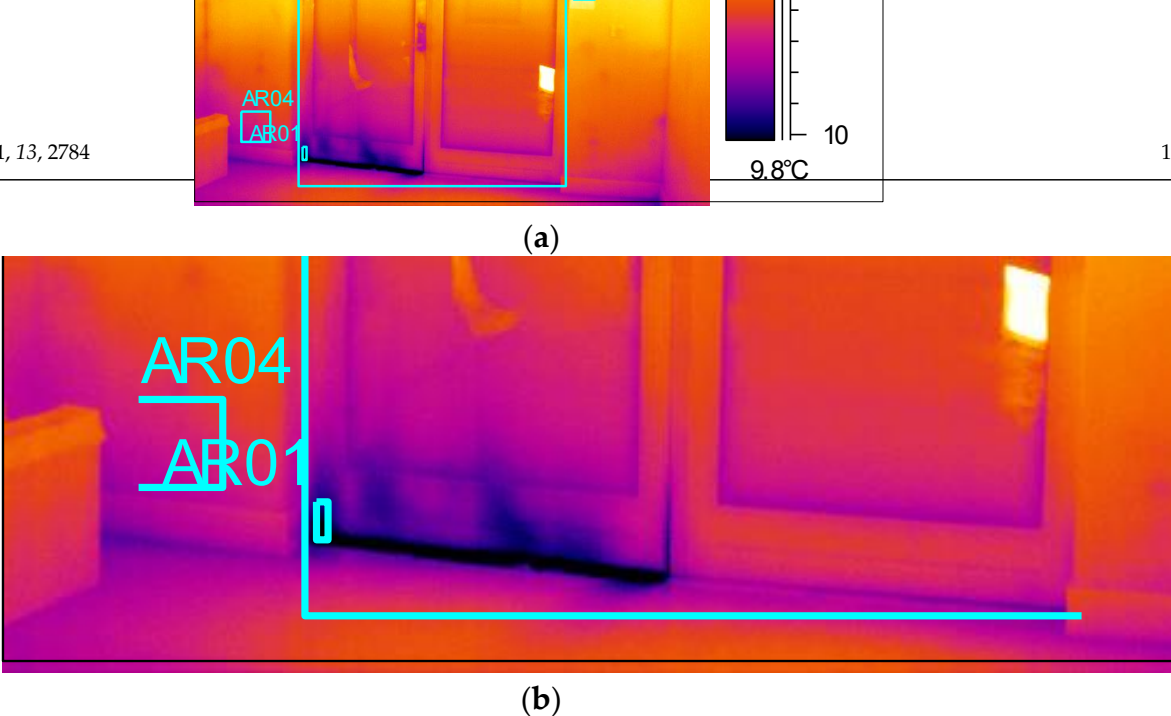
Figure 9. Rear door of ZP2 during depressurization: (a) thermal image; (b) close-up of air leakage on right.

ZP2 showed similar signs (to ZP1) of air leakage throughout the property; the skirting board areas were common areas where air leakage was observed and around the openable elements. Special attention should be paid to the doors within the property wherein all of these showed signs of significant cooler temperature along the lower half. However, this may be due to the problem with heating that was present within this property. The rear door can be seen in Figure 9, during depressurisation the air leakage path has increased as expected, these areas would have benefited from having a suitably trained individual inspect this area to ensure adequate sealing is present. In this image, the TI is 0.35 under depressurisation but 0.44 before depressurisation. These results could indicate significant condensation around the lower section of the door frame.

air leakage was observed throughout the property; the skirtage was observed and around the doors within the property. The temperature along the lower half of the doors was present within this property. Under depressurisation the air leakage path was observed. The property benefited from having a suitably sealed door. In this image, the air leakage is present. In this image, the air leakage is present. These results could indicate significant air leakage of the door frame.

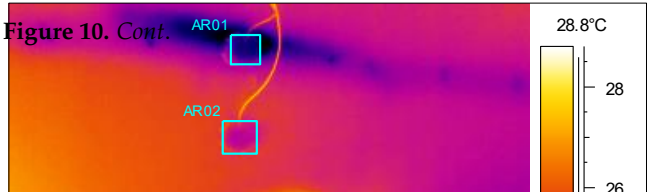
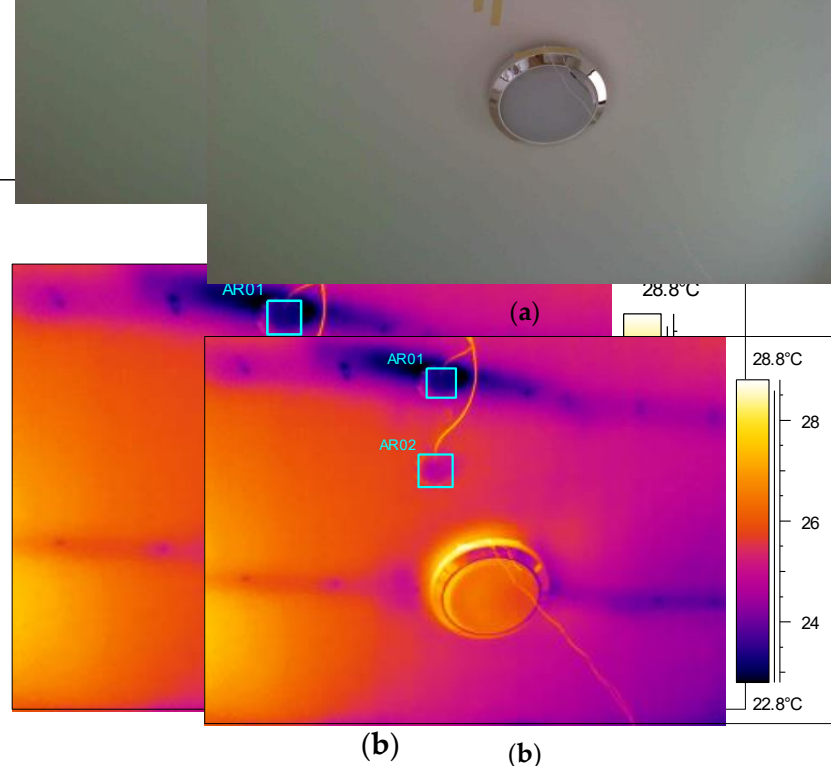
Figure 10. Heat flux measurement on Bathroom ceiling of ZP2: (a) photograph; (b) thermal image.

Overall heat flux measurements showed poor thermal quality of the walls and roof section that were measured. Whereas ‘good’ and ‘poor’ quality sections were measured, even the ‘good’ quality sections did not meet the design U-values. The measured values of thermal transmittance for the walls of the dwellings were found to be significantly higher than design values as shown in Table 8. In fact, the measured external wall U-values do not meet UK Building Regulations limiting fabric parameters ($0.30 \text{ W/(m}^2\cdot\text{K)}$). The measured values are eight times the design value, but the ‘poor’ area corresponding to a roof joist was $1.28 \text{ W/(m}^2\cdot\text{K)}$ which is eight times the design value. Figure 10 shows the heat flux measurement locations on the ceiling and Figure 11 shows the heat flux measurement data for the measurement period in ZP2.

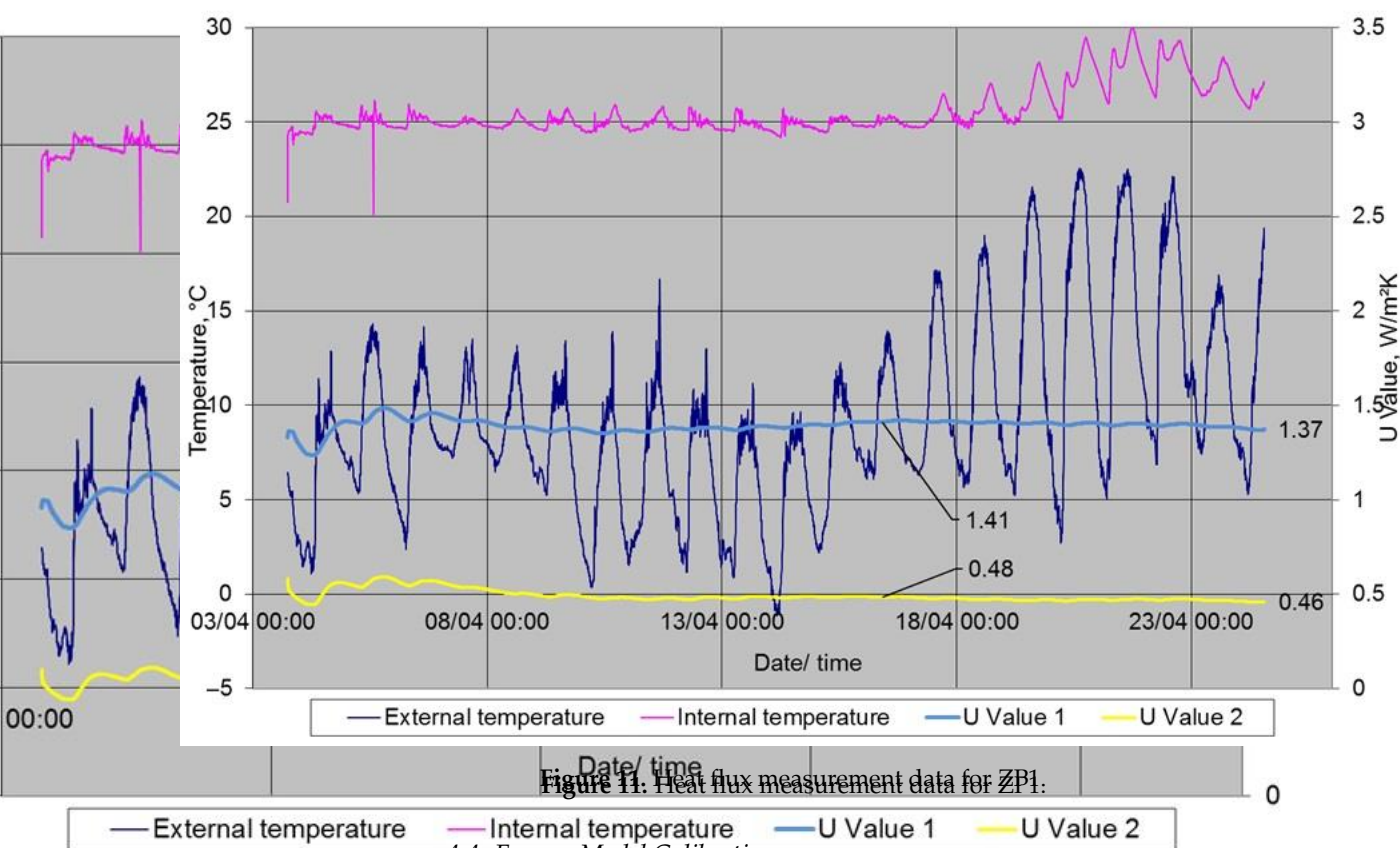
Figure 11. Heat flux measurement data for ZP1.

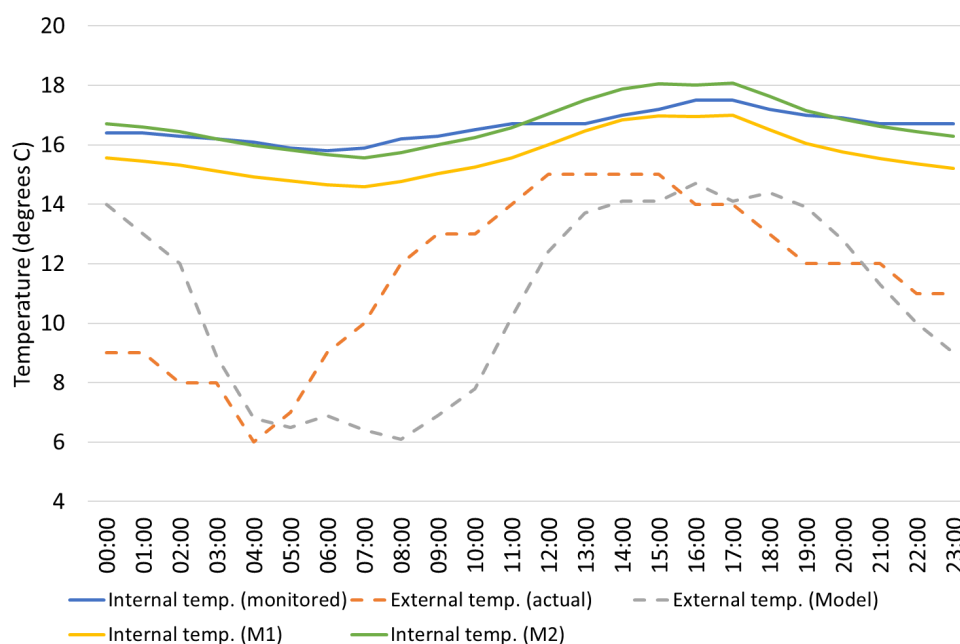
Figure 12. Internal and external measured and simulated temperature data 10 September 2019 in ZP2.

Figure 12 shows one day during the temperature alignment process (10 September 2019). External and internal temperatures are shown for M1 and M2. M1 resulted in 1°C cooler internal temperatures in the model than what was monitored for the same period. For M2 validation using hourly temperature data for monitored period, the uncertainty result of NMBE was 0.8% and the result of CV(RMSE) was 5% for the as-built calibration, well below the required 10% and 30%, respectively.
