Baiche, B., Osmani, M., Walliman, N. and Ogden, R. (2017) 'Earth construction between tradition and modernity: Case studies on Algeria', *Proceedings of the ICE - Construction Materials*, 170 (1), pp. 16-28.

Title of submission: **Earth construction between tradition and modernity: Case studies on Algeria**

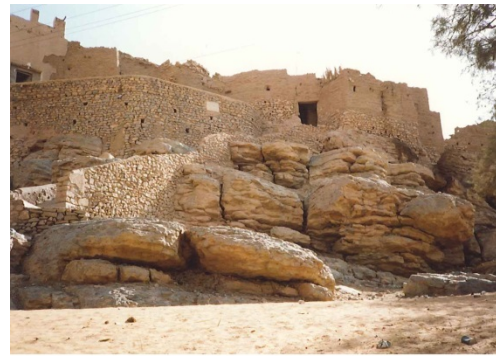
Figure 3. Rocky site on which the Ksar of Taghit was built. Bottom part of walls built with stones joined with earth-based mortar.

In Taghit, the vernacular houses of the Ksar do not have conventional foundations. The entire Ksar stands on an immense rocky site (Figure 3); the bases of the walls and columns, erected directly on the rocky site, were reinforced with stones to make the plinth walls. The stones were joined with earth mortar, but due to poor workmanship, and to the low resistance and durability of the earth-based joint mortar, much of the latter has been eroded and washed away making the stones protruding. As a result the resistance within the bases of walls and columns is compromised.

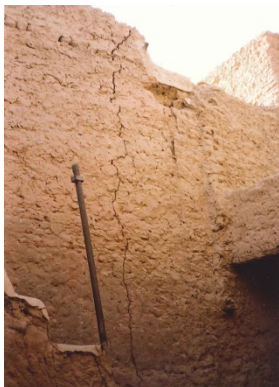
Figure 4. A vertical crack running across the full height of a wall of a vernacular dwelling in Taghit.

Walls of the vernacular dwellings in the Ksar of Taghit were built with hand-made, loaf-like earth bricks with no standard dimensions. As a result, not only the thickness of the walls varied, but several walls were neither vertical nor straight. In addition, the poor workmanship of the local indigenous earth technique, led walls in many dwellings to exhibit a variety of cracks, some even severe at wall corners (Figures 4, 5 and 6). Another problem was the poor grip between the earth material and the frames of the door and window openings aggravated by violent slamming of doors and windows. Several walls have been eroded by occasional rains and frequent, violent winds and sandstorms.

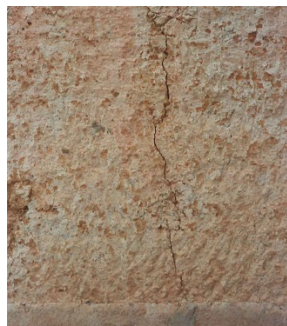
When surveying the rammed earth housing in Mostefa Ben Brahim, a pattern of vertical cracks was identified on the external walls of the dwellings. Each external wall appeared to have a number of vertical cracks. Some of these cracks were visible inside and outside, implying that they were potentially deep cracks running across the thickness of the walls, others were visible only from one side. This did not however mean that they were only superficial cracks (Figures 8 and 9).

Figure 8. A vertical crack running across the full height of a wall of a rammed earth house in Mostefa Ben Brahim. Note the crack passing through the filled holes of the shuttering crosspieces.

The causes of these vertical cracks are not obvious but there is a high probability that the holes of crosspieces which supported the shutterings, being weakness points in the construction, contributed to these cracks. This claim is supported by CRATerre in their report. This is also backed up by anecdotal evidence from a local builder who was working on the site during the implementation of the scheme. He claimed that each time they were removing the shutterings and the crosspieces supporting them, they knocked the crosspieces hard to get them out of the wall which was still wet at that stage. As a consequence, the vibrations might have been transmitted through the wall at its weakness points, thus causing these vertical cracks. The sizes of the different particles and lumps in the soil used and its nature might have also contributed to these cracks. In addition, many of these vertical cracks run the full height of the walls, even through the plinth walls as discussed earlier. A number of possible assumptions of the causes of these cracks can be made, i.e. foundation failure, including support settlement, heave in clay soils, or any overloading, or thermal movement.

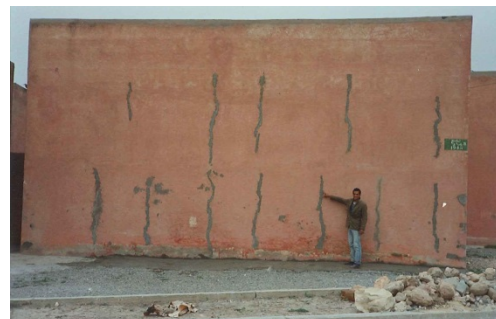
Figure 9. The pattern of vertical cracks identified on the external rammed earth walls of the houses in Mostefa Ben Brahim.

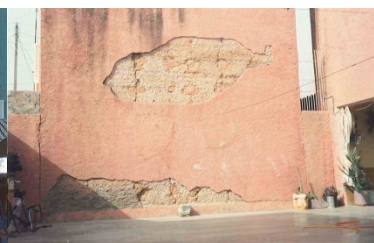
The main problems observed consisted of bulging, cracking, and patches where rendering was missing altogether. The external rendering of all of the recorded houses in Mostefa Ben Brahim, especially those still coated externally with roughcast showed vulnerability of such type of cladding (Figure 11). The areas where rendering was either missing or cracked could be observed using the naked eye. However, bulging (suggesting rendering/wall debonding) was detected by knocking gently on the rendering with a clenched fist. These types of problems were not restricted to roughcast finish, but were also visible on the external rendering of houses with other types of rendering. The external rendering of many of these houses exhibited hairline cracks and some small patches of missing rendering. In one case, it was noticed that the whole external rendering had been re-done completely using cement-based mortar which suggested that failure of the original roughcast rendering.

Figure 11. Vulnerability of the roughcast rendering used for the rammed earth houses in Mostefa Ben Brahim. Note the vertical cracks on the wall and black patches at the top of the wall.

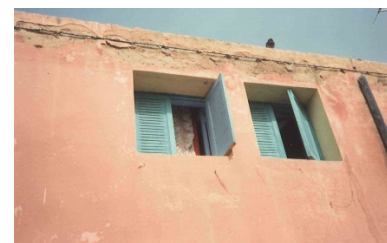
When the only downpipe was blocked, the eaves gutter filled with water which then would overflow at the ends and middle of the eaves gutter. The effect of this problem is clearly visible at the top of south facades of the majority of houses, such as spalling and flaking of rendering (Figure 12).

Figure 12. Vulnerability of rendering at the top of an external wall of a rammed earth house in Mostefa Ben Brahim, showing spalling of the rendering.

Failure of the external rendering of the stabilised rammed earth houses in Mostefa Ben Brahim, was in several cases exacerbated by the inefficient rain water evacuation system. The inefficiency of the rain water pipe system was attributed to the pipe material, diameter, number and location of the pipe. One downpipe was provided for the evacuation of the rain water from the roofs of the houses. The pipe, whose diameter was between 10-12 cm, was made of PVC, and fixed to the middle of the eave gutter on the south facade. It was claimed that because of its narrow diameter, the pipe sometimes became blocked by dirt, dust or dead animals such as pigeons.
