# Earthquake Safety Assessment of Buildings through Rapid Visual Screening

**Abstract:** Earthquake is among the most devastating natural disasters causing severe economical, environmental, and social destruction. Earthquake safety assessment and building hazard monitoring can highly contribute to urban sustainability through identification and insight into optimum materials and structures. While the vulnerability of structures mainly depends on the structural resistance, the safety assessment of buildings can be highly challenging. In this paper, we consider the Rapid Visual Screening (RVS) method, which is a qualitative procedure for estimating structural scores for buildings suitable for medium- to high-seismic cases. This paper presents an overview of the common RVS methods, i.e., FEMA P-154, IITK-GGSDMA, and EMPI. To examine the accuracy and validation, a practical comparison is performed between their assessment and observed damage of reinforced concrete buildings from a street survey in the Bingöl region, Turkey, after the 1 May 2003 earthquake. The results demonstrate that the application of RVS methods for preliminary damage estimation is a vital tool. Furthermore, the co

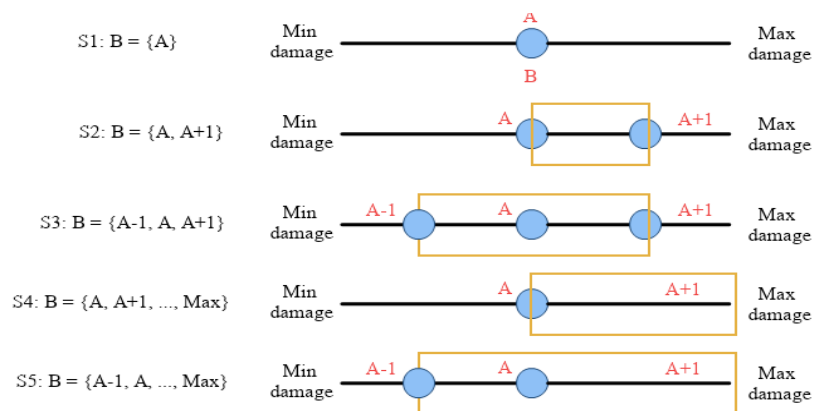
Figure 2. Set representation of each similarity.

Figure 2 illustrates the set representation of each similarity where  $A$  indicates the actual damage,  $B$  is the RVS damage,  $+1$  or  $-1$  indicates the increase and decrease in damage, respectively. Achieving final decisions based on similarity 1 alone is not advisable, as the results may not always be exact. Similarity 4 should be considered if safety was of primary concern irrespective of cost and time it takes for a detailed assessment of more buildings. Similarity 2 and 3 provide closeness of RVS methodology to actual damage. Similarity 5 was performed only to check how many building estimates were

**Similarity 1:** Number of buildings in RVS methodology giving exact damage as that of actual damage.

**Similarity 2:** Number of buildings in RVS methodology giving exact damage as that of actual damage + number of buildings with one-step severe damage. For example, if actual damage was four and RVS methodology gave three, which was one step more severe than four, that will also be counted in this similarity.

**Similarity 3:** Number of buildings in similarity 2 + number of buildings within one step damage. For example, if the actual damage was four and RVS methodology gave any of three, four, or five, then it will be counted in this similarity.

**Similarity 4:** Number of buildings in RVS methodology giving exact damage + number of buildings with more severe damage. For example, if actual damage was four and RVS methodology with four, three, two, and one, the damage state will be counted in this similarity.

**Similarity 5:** Number of buildings in similarity 4 + number of buildings with one step less severe or two steps more severe damage. For example, if actual damage was three and RVS methodology gave any of four, three, two, and one, then it will be counted in this similarity.

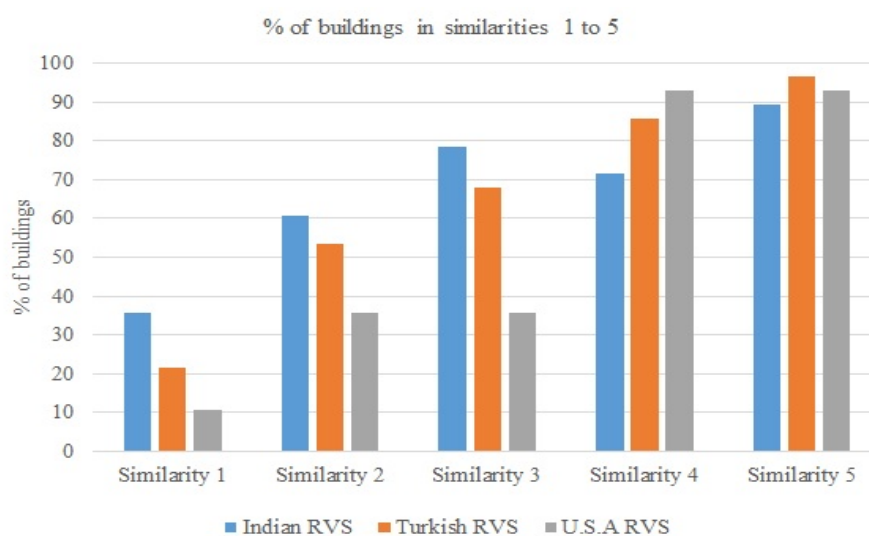
Figure 3. Percentage of buildings in each similarity from RVS methodologies.

It has been inferred from the graph that in similarity 1, 2, and 3, Indian RVS presented a large amount of buildings as did Turkish RVS, but FEMA P-154 addressed a fewer number of buildings in the first three similarities. In similarity 4 and 5, FEMA P-154 assessed 93 percent of buildings, Turkish RVS addressed 80 percent of buildings, and Indian RVS presents a fewer number of buildings compared to the other two RVS methodologies shown in Figure 3.

inaccurate. As the results from similarity 5 are more than 90 percent of buildings, it has not been used for conclusion purposes. The results for all five similarities from three RVS methodologies are illustrated in Figure 3.

It is clear that FEMA P-154 gives higher damage grade even for buildings with fewer negative influential parameters, although the damage may not be severe. On the other hand, in Indian RVS, similarity 2, 3, and 4 are close to each other with only 10 percent, indicating most of the buildings that were in similarity 4 were also in similarities to 2 and 3. This means Indian RVS provided closer results to the actual damage followed by Turkish RVS. It would be of interest to check the numbers of buildings categorized in damage state 1 by RVS methodologies before coming to a conclusion. This damage state included both damage grades 1 and 2, and hence, the damage state 1 from RVS methodologies will be compared against grades 1 and 2 of actual damage. The RVS methodology with the most accurate assessments of damage versus actual damage can be considered the most efficient methodology.

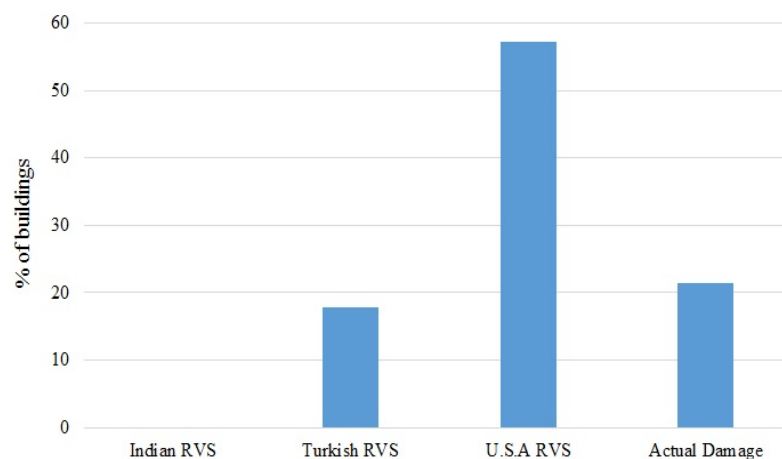
**Figure 4.** Percentage of buildings in damage state 1 assessed by different RVS methodologies.

Figure 4 shows a clear trend that FEMA P-154 estimated almost 58 percent of buildings as damage state 1, which was not appropriate in consideration, as there were fewer buildings that showed state 1 and 2 in the actual damage data. Meanwhile, Indian RVS did not estimate any building as damage state 1, which is also not acceptable as there are fewer buildings having damage grade 1 and 2 in the actual building data. Moreover, Turkish RVS provided around 17 percent of buildings as damage state 1, which can be accepted, as around 20 percent of buildings were actual damage state 1 and 2.

According to the similarity level, although Indian RVS is significant, it can be highlighted from Figure 4 that Indian RVS might not be considered as a suitable method since it did not classify any building in damage state 1. It is very hazardous for health safety if a building can suffer more severe damage but has been estimated as a moderate or lighter damageable building. For this reason, the Turkish method can be preferred among the three RVS methodologies and also in similarities, as Turkish RVS was close to the results of Indian RVS. However, the RVS methodologies may not give the same damage as that of the actual damage; hence, the best method must be selected based on the requirement of the user.
