Integrating historical, geomorphological and sedimentological insights to reconstruct past floods: Insights from Kea Point, Mt. Cook Village, Aotearoa New Zealand

R.D. Williams, H.M. Griffiths, J.R. Carr, A.J. Hepburn, M. Gibson, J.J. Williams, T.D.L. Irvine-Fynn

To appear in: *Geomorphology*

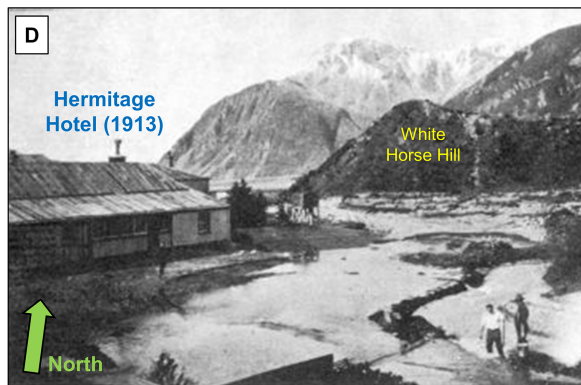
The Mueller Glacier is one of these 12 large lake-terminating glaciers and has shrunk dramatically since the Little Ice Age (LIA; Figure 1 and Figure 2), which is estimated to have occurred between ~1450 and 1850 CE in the Southern Alps (Lorrey et al., 2011). Much of the glacier ablation area is covered in rock debris, which has resulted in uneven surface downwasting, at rates of 0.5-1.2 m/a since ~1900 (Burrows, 1973, Robertson et al. 2012), and the formation of ice surface ponds (Kirkbride, 1993; Rohl, 2008; Figure 1 and Figure 2). These ponds have enhanced melting and coalesced, facilitating rapid growth of the proglacial Mueller Lake (Robertson et al., 2012), at rates of 130 m/year between 2000 and 2018 (Pelto, 2018). Mueller Lake formed from ~1900 and is enclosed by an arcuate moraine complex characterised by a series of nested ridges (Burrows, 1973; Barrell et al., 2011; Figure 1 and Figure 2), with maximum moraine ridge crest elevation ~120–150 m above the contemporary lake level (Allen et al., 2009). The series of ridges have been subject to a variety of studies aimed to resolve the processes and timing of their formation (Burrows, 1973; Gellally, 1984; Winkler, 2000; Schaefer et al. 2009; Kirkbride and Winkler, 2012; Reznichenko et al; 2016).

We use an integrated approach to examine an historical natural hazard event observed in the Aoraki Mount Cook region of Aotearoa New Zealand in 1913, where heavy rain caused waters from Mueller Glacier to overtop the moraine at Kea Point (Figure 1; Figure 2). This event destroyed the original Hermitage Hotel (Figure 2D) and for which a rich documentary archive exists. Our aim, here, is to reconstruct the GLOF by integrating historical archival materials, that provide insight into the timing and spatial impact of the GLOF, with geomorphological and sedimentological analyses to provide information about processes of the GLOF itself. Our results are presented in the style of a source-pathway-receptor model (Holdgate, 1979); source refers to the origin of floodwater, pathway to flood routing and receptor the impact of the flood in terms of geomorphic change and damage to people, property and/or infrastructure. Evidence is collated from different sources, and employed to reconstruct the GLOF trigger(s), timeline, peak discharge, geomorphological impact, and consequences for people and property. The discussion (i) evaluates the insight gained from integrating interdisciplinary data, (ii) identifies limitations and how other datasets could augment the reconstruction and (iii) develops a framework summarising how different observational and archival sources can be used to reconstruct different phases of flood events.
