Assessment and evaluation of the values and threats affecting abandoned agricultural terrace environments in Il-Majjistral Nature and History Park, Malta

Context:

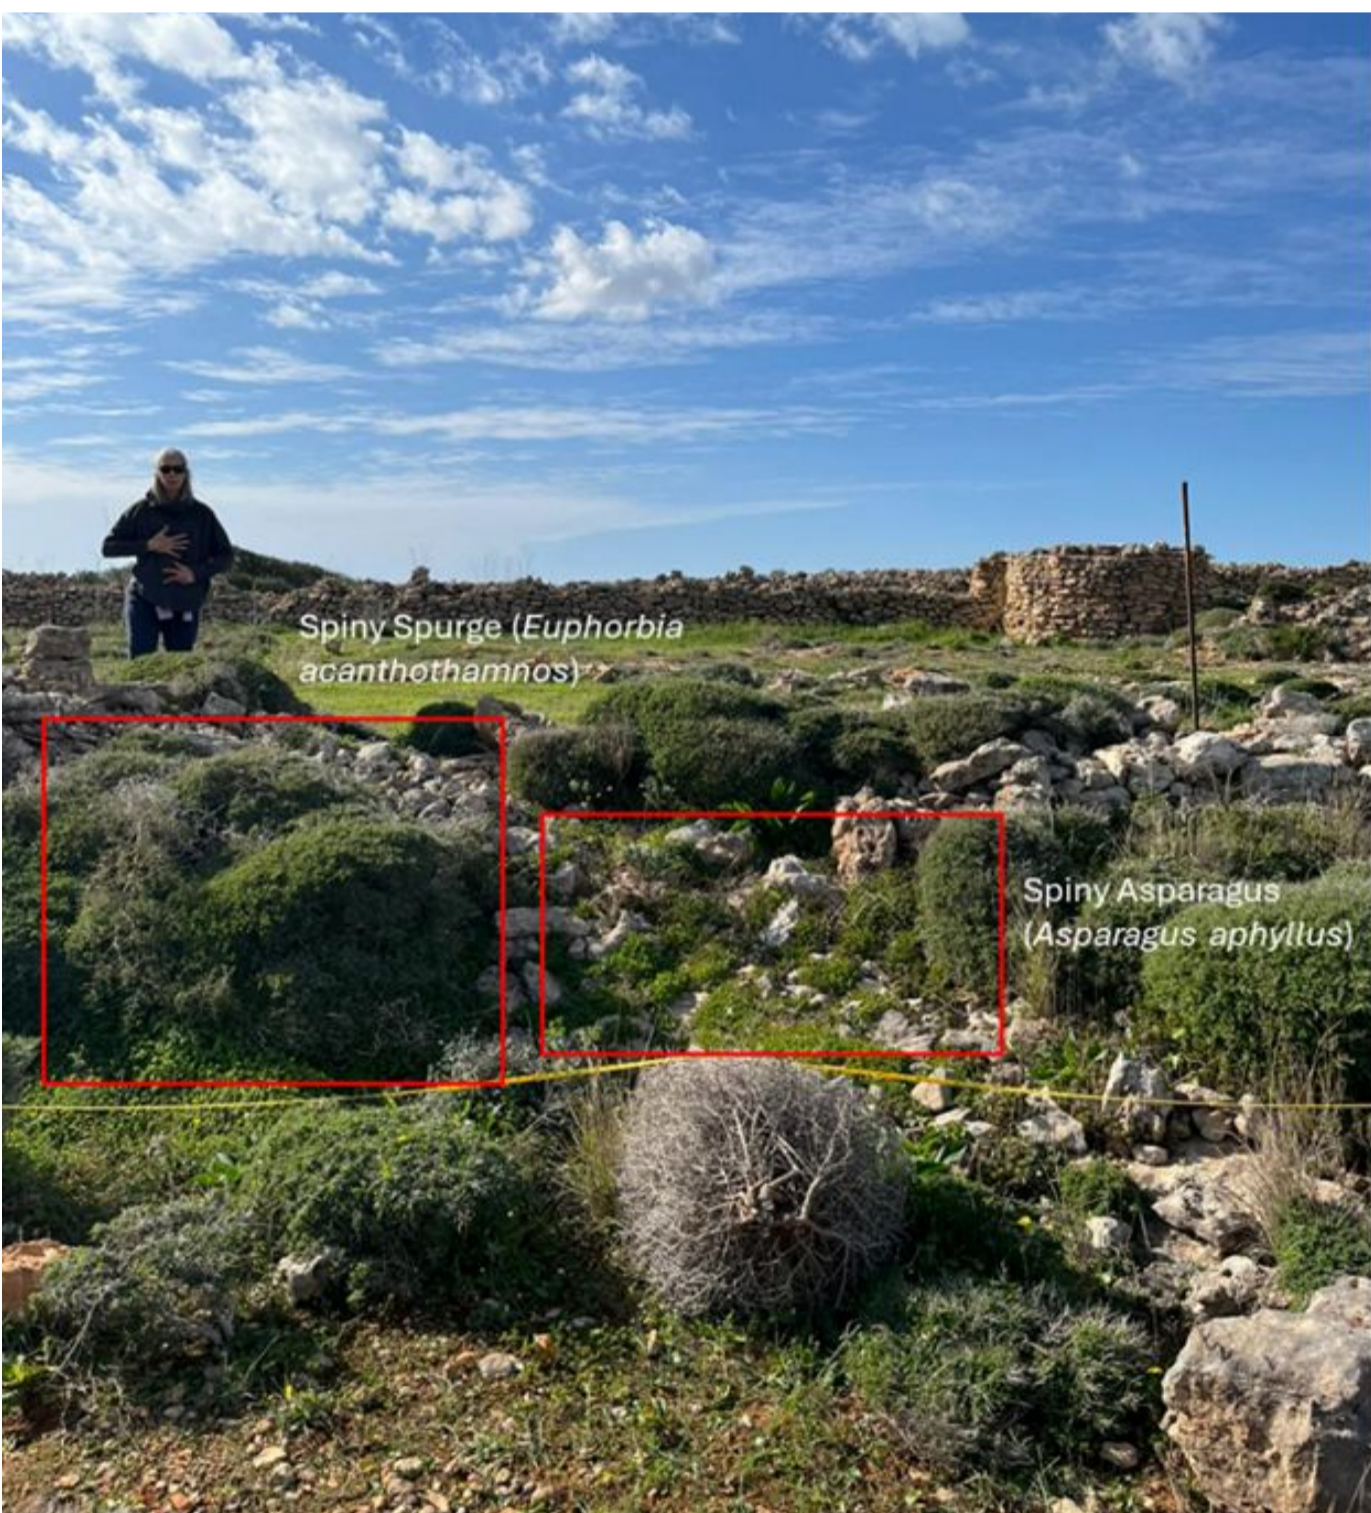
Photograph of (Upper Wall transect 8) UW8 section, displaying evidence of vegetation populating the terrace rubble wall

- In the case of rockfall, vegetation growth may be a sign of degradation and biological weathering, but the removal of such non-invasive plant colonies may damage the biodiverse value of the site

- Rubble walls could be built up where total wall height is too low and wall width is too thin, especially where height hits 0.55m and below, which corresponds to soil breach presence. Rubble wall restorations are already in place across the park (The Majjistral Nature and History Park, n.d b), making this a possibility.

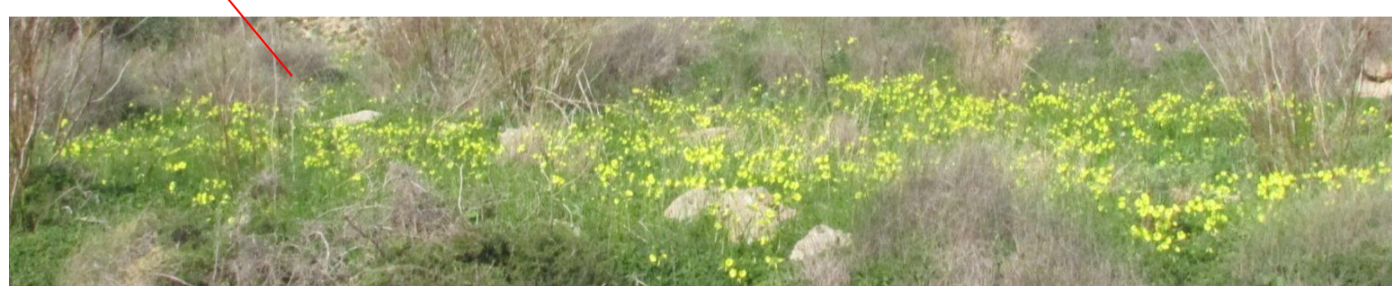
A cluster of Bermuda Buttercup that has invaded another coastal abandoned terrace (source: Author). Many rubble walls at this location had collapsed and Bermuda Buttercup dominated the area.

- Targeted removal procedures and monitoring of invasive species. Strategies as such are in place across the park (The Majjistral Nature and History Park, n.d a), therefore applying this to species like Bermuda Buttercup on terraces is possible and beneficial to stop invaders outcompeting rare, endemic, or at risk species.

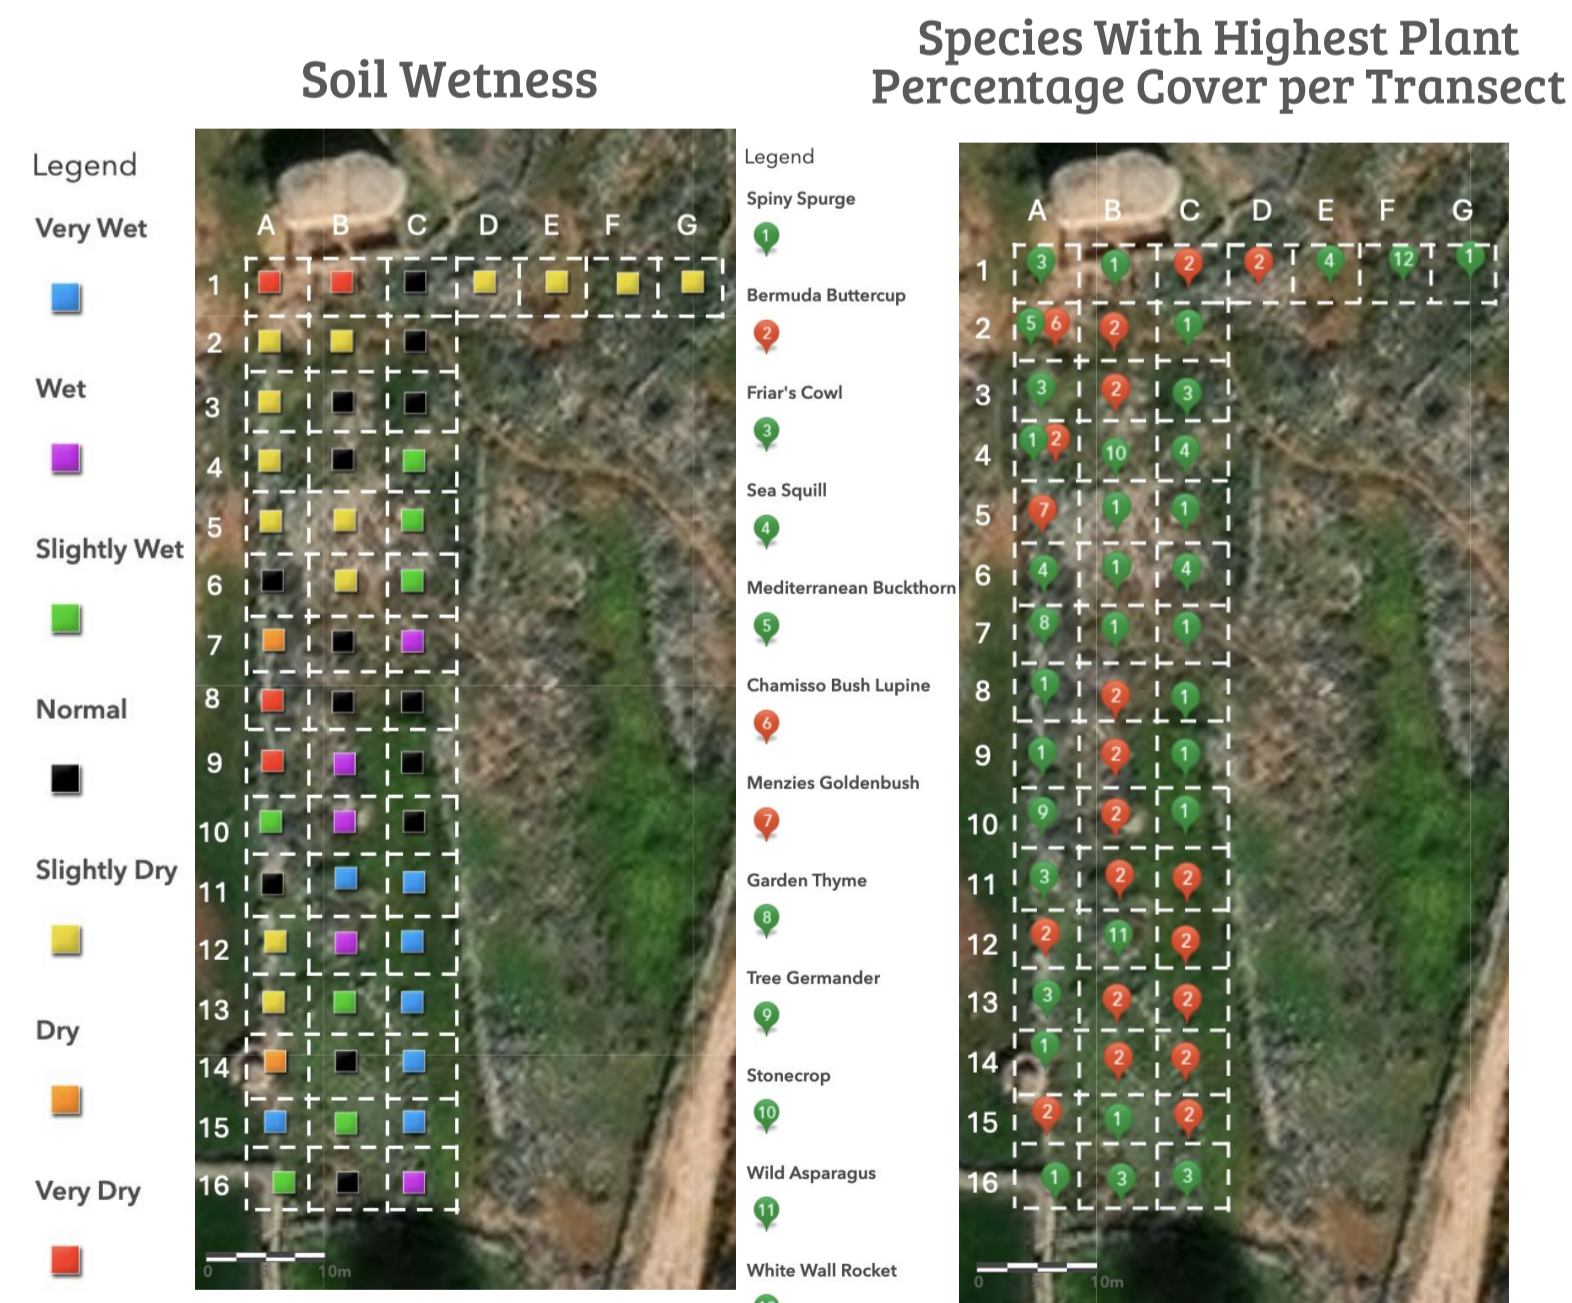
Two maps of the study area showing soil wetness and the species with the highest plant percentage cover for each transect (Source: Esri, Maxar). Species map: species 1-4 are ranked by frequency, 1 occurring the most and 4 occurring the least, but occurs more than once. Species numbered 5-11 occur once and are not ranked specifically. Red markers indicate invasive alien species, green markers indicate native plants. Wetness map: wetness was measured using a finger texturing technique and has been ranked on a seven-point scale as appears in the legend.

- Soil conditions were wetter around the middle and front of the terrace, but dryer at the back of the terrace and near footpaths, indicating that water in abandoned terraces mobilise similarly to active terraces. Variations in soil moisture may be due to different flora and fauna that would not be present on active terraces.
