# Evaluation of Cavitation Erosion Behavior of Commercial Steel Grades Used in the Design of Fluid Machinery

I. TZANAKIS, L. BOLZONI, D.G. ESKIN, and M. HADFIELD

The erosion response under cavitation of different steel grades was assessed by studying the erosion rate, the volume removal, the roughness evolution, and the accumulated strain energy. A 20 kHz ultrasonic transducer with a probe diameter of 5 mm and peak-to-peak amplitude of 50  $\mu\text{m}$  was deployed in distilled water to induce damage on the surface of commercial chromium and carbon steel samples. After a relatively short incubation period, cavitation induced the formation of pits, cracks, and craters whose features strongly depended on the hardness and composition of the tested steel. AISI 52100 chromium steel showed the best performance and is, therefore, a promising design candidate for replacing the existing fluid machinery materials that operate within potential cavitating environments.

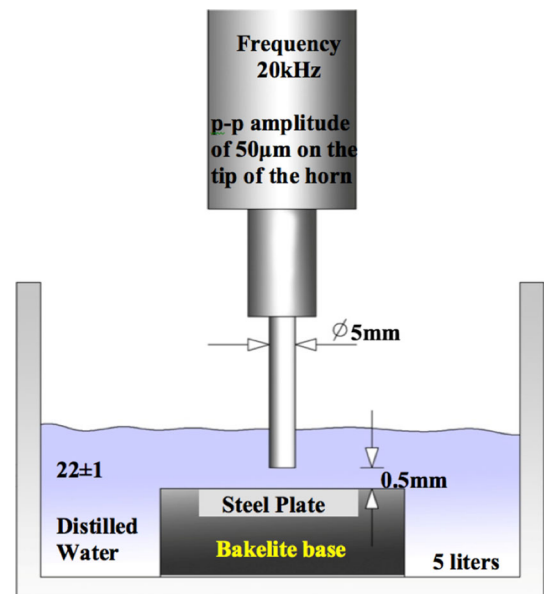
Fig. 1—Schematic overview of the ultrasonic vibratory method used for cavitation tests.

Cavitation erosion tests were carried out based upon the set up shown in References 3, 5, and 32. An ultrasonic transducer at a frequency of 20 kHz and a peak-to-peak vibratory amplitude of 50 μm was deployed. Vibrations were introduced in the liquid media using a stepped titanium probe with the 5 mm diameter. Steel samples were mounted on the bottom of

a large transparent tank (dimensions 40 × 20 × 15 cm<sup>3</sup>) filled with 5 liters of distilled water. The tip of the titanium horn was submerged to a distance of 0.5 mm from the top of the steel sample (Figure 1). Cavitation created by the small size probe generated a gradual damage that was useful for studying the mechanisms of cavitation erosion, while the energy released by cavitation did not significantly affect the water temperature that was maintained at 295 ± 1 K (22 ± 1 °C).

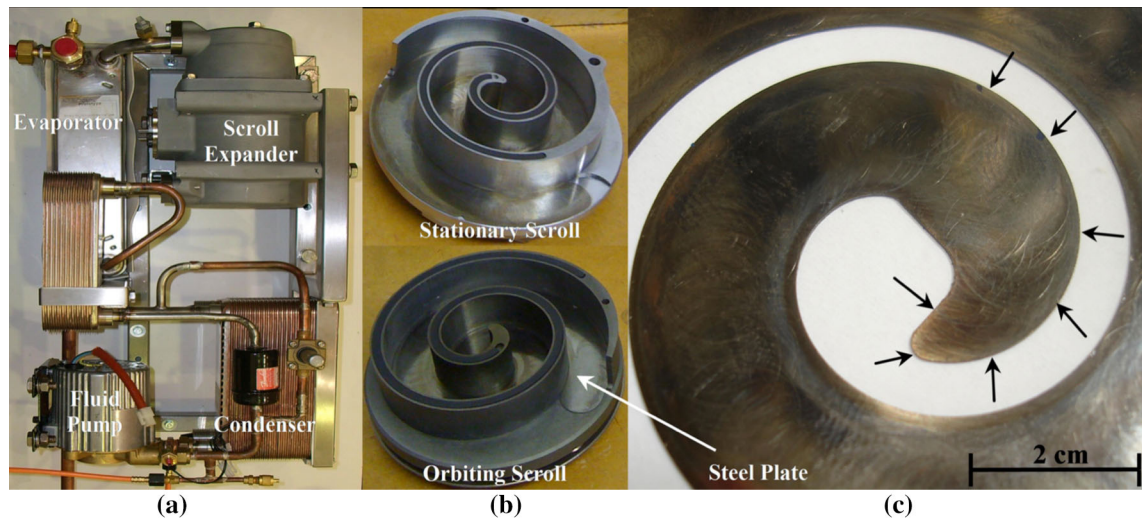
Fig. 2—Photos of the  $\mu$ -CHP unit studied: (a) assembled system, (b) stationary and orbiting involute scrolls, and (c) cavitation-affected zones on the scroll plate analyzed.

A detailed surface examination of the AISI W1 steel plates (Figure 2(c)) of the scroll expander system, after its service period of 1000 hours as the main part of an experimental  $\mu$ -CHP unit, was performed. The scroll expander and its individual components are shown in Figure 2. A full account upon the specific scroll expander technology and its operational conditions can be found in Reference 37. Results showed that cavitation erosion across the steel plate of the scroll expander is one of the main mechanisms, apart the primary tribological mechanisms governing the contact of the two involute spiral scrolls discussed in previous studies,<sup>[38,39]</sup> which can seriously affect the lifecycle of a scroll system.

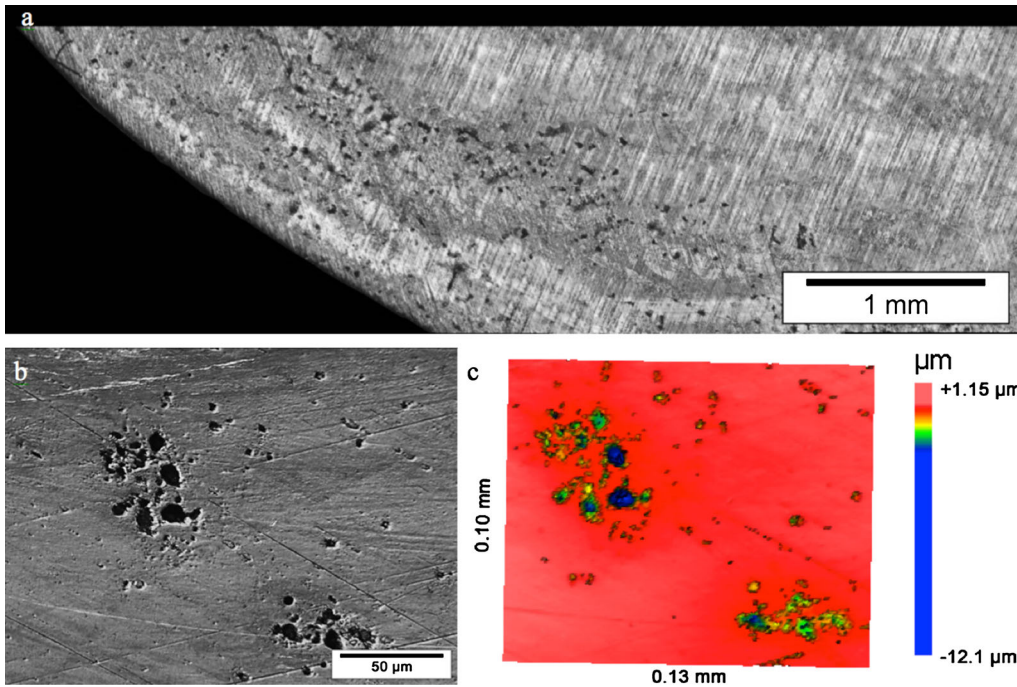
Fig. 3—Details of the cavitation eroded AISI W1 steel plates: (a) cavity clusters found in the high-pressure region of the scroll expander, (b) optical micrograph of the cavity clusters, and (c) ZYGO interferometer analysis of the cavity clusters.

Specifically, many cavitation pit clusters were identified across the steel plate (indicated by black arrows in Figure 2(c) and seen in detail in Figure 3), in the area close to the high-pressure region in the suction port of the scroll. The cavities were mainly accumulated along the edges of the steel plate, creating a continuous layer of cavities of approximately 1.5 mm wide. In the low-pressure regions of the steel plate, no traces of cavities were found. The mechanism dominating the formation of cavities in these particular high-pressure regions was explained in detail elsewhere.<sup>[1,2]</sup> The appearance of the eroded steel plate where cavity clusters were formed is shown in Figure 3(a). These clusters consisted of cavitation pits, which accelerated the cavitation process by forming deeper and wider cavities that would be eventually transformed into deep craters. Dular *et al.*<sup>[40]</sup> stated that these cavity clusters varied significantly in size and shape compared to individual cavitation pits and they tended to grow much faster. Due to their arbitrary and irregular shape, they became favorable nucleation spots for cavitation bubbles to grow and to implode, leading to the reduction of the resistance of the material in that region. Typical examples of the cavity clusters found in the steel plate are shown Figure 3(b).

From interferometer data (Figure 3(c)), key dimensions (depth and diameter) of the individual pits found across the steel plate were accurately calculated and presented as histograms of Figure 4. A total number of 110 individual pits were analyzed across the steel plate. The frequency distribution shows the probability of these two geometrical parameters among the measured cavitation pits. The average diameter was in the range of 10 to 20  $\mu\text{m}$ , while the average depth was in the range of 1 to 2  $\mu\text{m}$ . The probability of cavitation-induced pits being larger than 3  $\mu\text{m}$  inside the scroll after that particular time duration was low, but still quite noticeable (about 20 pct possibility). Similarly, the probability for the formation of pits with diameters higher than 30  $\mu\text{m}$  was low. The growth of cavitation clusters was

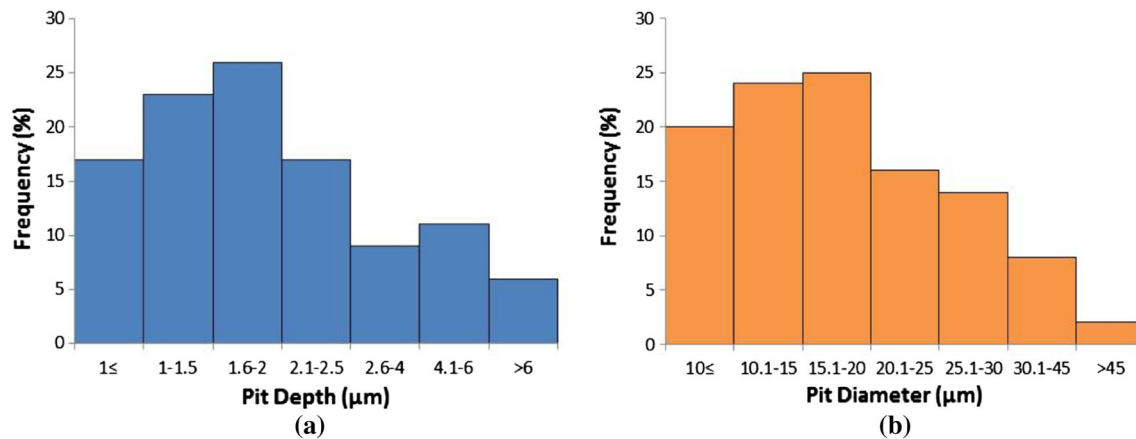
Fig. 4—Histogram of (a) pit depth and (b) pit diameter distribution in the actual part of the scroll steel plate after its service period of 1000 h. Results are from the analysis of 110 pits.

caused largely by linking up of nearby cavitation pits. The process of their enlargement, transforming their shape into deep craters, was dependent on time and history. According to Howell,<sup>[41]</sup> the gap between the scrolls is typically 1  $\mu\text{m}$  across. However, this may be increased by cavitation impacts, and it is known that if it reaches around 8  $\mu\text{m}$ , the scroll can become inefficient.

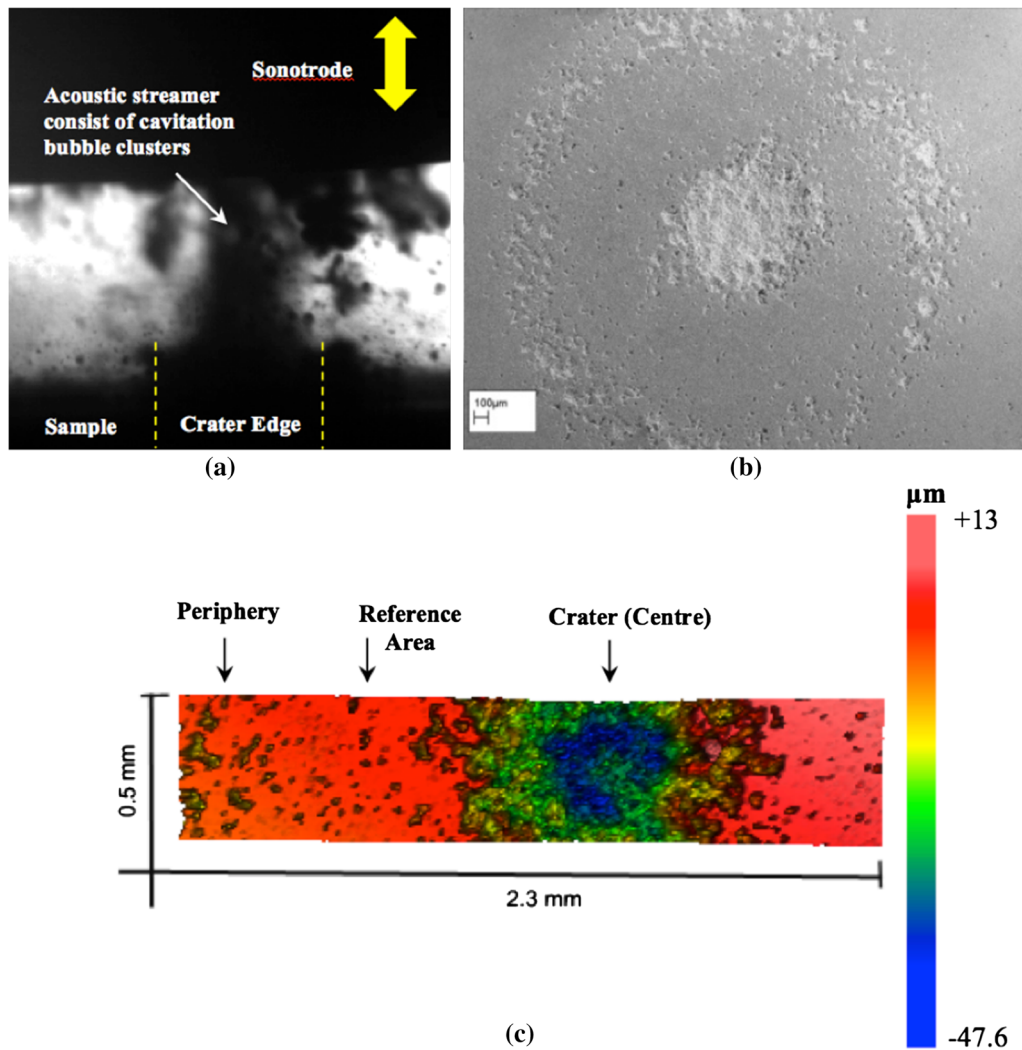
Fig. 5—Details of a cavitation ring area: (a) image of the high speed acoustic stream which consists of cavitation bubbles, (b) SEM micrograph of the outer annulus and the crater of the ring region, and (c) ZYGO interferometer image of the eroded area.

The cavitation pits formed in the early stages of cavitation (described in Reference 31) significantly grew by agglomeration of nearby pits, cracks, and grooves. The surface roughness substantially increased, accelerating the erosion rate of the materials. The enlargement of the pits was accompanied by the additional volume loss. The mechanism of pit growth leads to the formation of deep and wide craters penetrating the surface of the sample. These regions are called “cavitation ring areas” because of their typical shape and an example, which is representative for the four steel grades studied, is shown in Figure 5.

Three different areas can be distinguished in the damage profile as shown in Figure 5(c): the centre (crater), the periphery (outer annulus), and the area between those two (reference area). Cavitation erosion is substantially larger, deeper, and wider in the centre compared to the periphery. The lowest damage is found in the area between the centre and the periphery (reference area) where erosion is superficial, being dominated by isolated cavitation pits (Figure 5(b)). A detailed description of this grading of erosion damage can be found elsewhere.<sup>[42]</sup> The intensity of cavitation is accumulated in the centre of the sample, as clearly indicated by the direction of the acoustic stream in Figure 5(a), (a full account of the cavitation high-speed monitoring process can be found in Reference 18) and also explained by Moussatov *et al.*<sup>[43]</sup> by the conicity of the acoustic stream where streamlines tend to focus in a centre point. Therefore, the damage in that particular

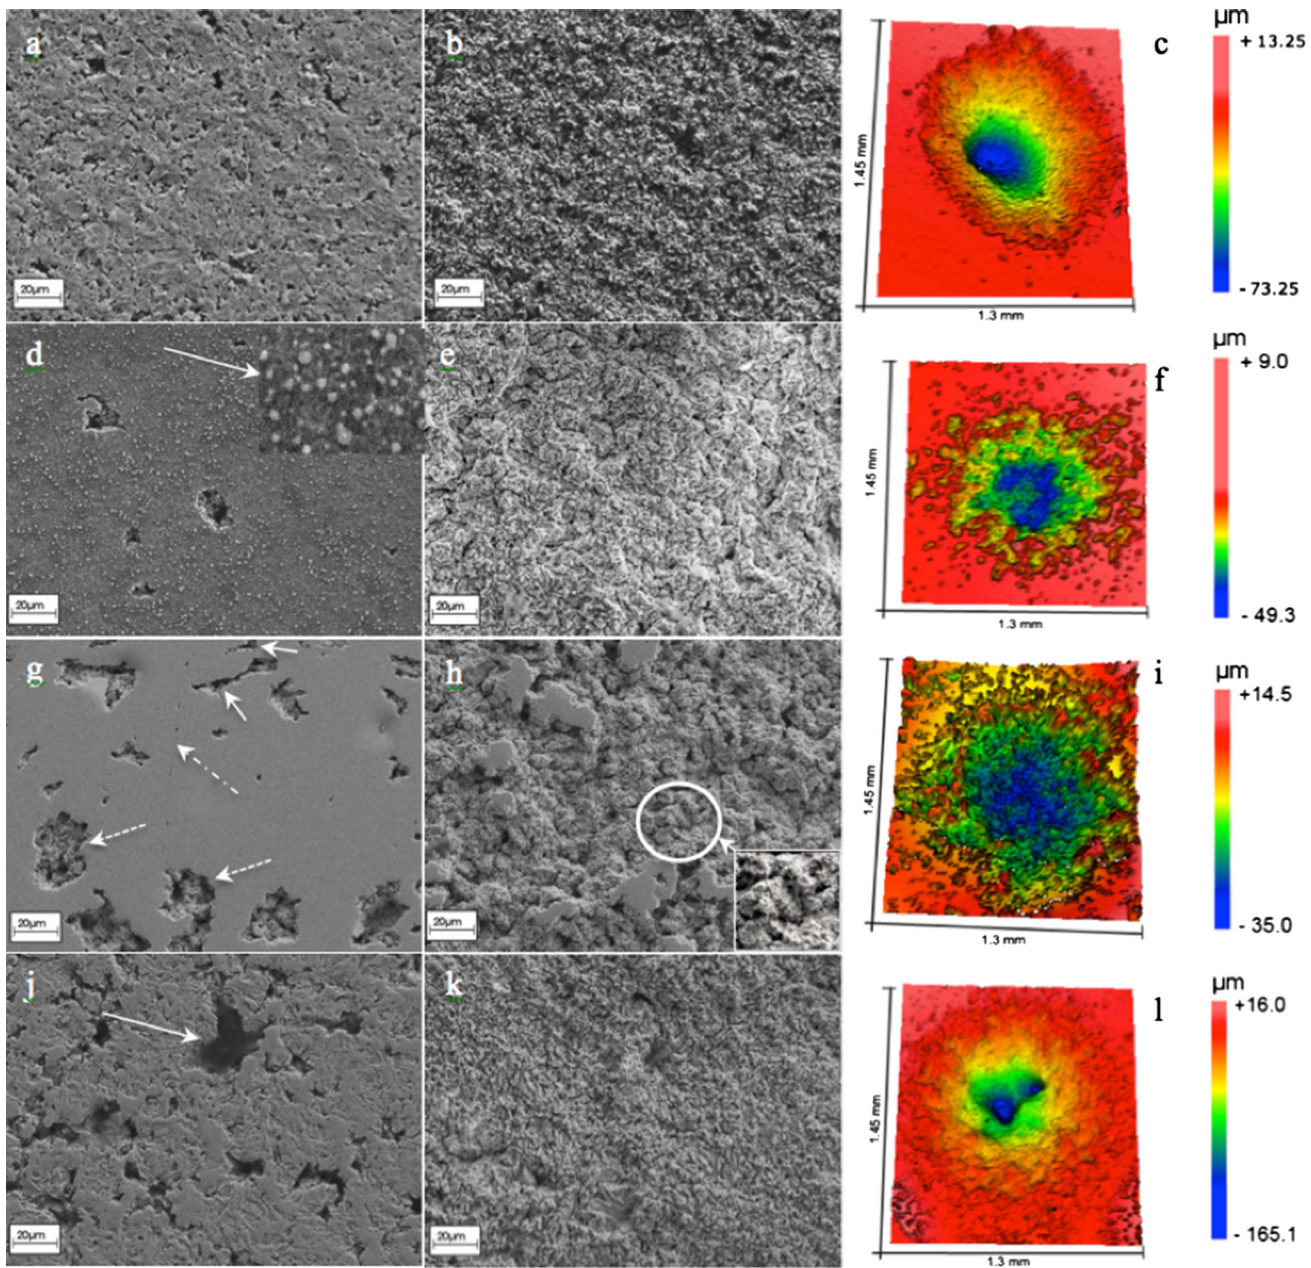
Fig. 6—SEM and ZYGO interferometer micrographs, respectively, showing the morphologies of the steel sample surface after 1 (*a, d, g, j*) and 8 (*b, c, e, f, h, i, k, l*) h exposure to cavitation erosion: *a–c*) AISI W1, *d–f*) AISI 52100, *g–i*) AISI 1085 and *j–l*) AISI 1020. (Color legends show the highest and lowest points for each micrograph individually and do not relate to each other. Results are explicitly presented in Table III).

Although the steel samples are characterized by different microstructural features (such as the presence of carbides) and different cavitation erosion resistance, they share similar brittle pattern of surface damage. This is illustrated in Figure 6 where SEM and optical

interferometer microscope micrographs are given. The damaged surfaces are characterized by the formation of pits, undulations, fatigue cracks, deep craters, and protruding steps as visible in the SEM images. The erosion features of the final stage are depicted by the interferometric micrographs. At the same time, each steel has some specific manifestations of the common features.

Figure 6(a) shows the initial stage of erosion pits and cracks formation after 1 hour of testing for the AISI W1 steel sample. Erosion mainly originated from pits and cleavage with their adjacent areas plastically deformed. As the cavitation time further increased, the pits coalesced and formed a larger crater. Gradually,

roughness increased, while the large craters coalesced and developed further to form a much larger crater, thereby leading to significant material removal. The surface layer was completely removed and a very rough surface was formed. The crater became progressively rougher and deeper with time. At the final stage of 8 hours (Figure 6(b)), erosive wear had sufficiently propagated, penetrating the surface, rapidly increasing the depth of the erosive region (Figure 6(c)).

Figures 6(d) and (e) shows the damage that occurred on the AISI 52100 steel surface. Chromium carbides approximately  $1 \mu\text{m}$  in size (appeared on the surface of the sample/blistering effect) emerged to the surface due to the consecutive impacts by the cavitation bubbles creating a reinforced substrate contributing to an increase in the strength of the material against cavitation erosion.<sup>[31]</sup> The stability of the surface was enhanced by the presence of fine, uniformly distributed carbides (Figure 6(d), in-set). However, when the matrix around these carbides became severely eroded, *i.e.*, after 8 hours, carbides were dislodged out of the surface of the sample. After 8 hours of exposure to

cavitation, surface was severely eroded forming a deep crater (Figure 6(f)).

Pits and numerous cracks were formed during the early stages of the cavitation erosion on the surface of the AISI 1085 sample, progressing into deep craters in later time steps (Figures 6(g) and (h)). The cracks were initiated at the surface (dash-dot arrow in Figure 6(g)) and spread perpendicular to it, while they tended to join together with the adjacent pits, forming deeper cracks that eventually transformed into small craters (solid arrows in Figure 6(g)). The absence of undulations and the detachment of large chunks (cleavage) of metal with an approximately diameter of  $20 \mu\text{m}$  (dashed arrows in Figure 6(g)) was an indication of surface brittleness. After sufficient exposure, the formation of microcracks was intensified, leading to crack propagation preferentially along the grain boundaries (intergranular fracture) (Figure 6(h), in-set) and brittle failure of the surface (Figure 6(h)). The erosion morphology is highlighted by the interferometric image taken in the core of the crater showing that the AISI 1085 sample had the best erosion resistance against the rate of penetration from the

acoustic stream (Figure 6(i)). However, this did not correspond to the highest erosion resistance against cavitation as the size of the crater is significantly larger compared to other steel grades, leading to larger amount of volume loss. A detailed analysis is conducted in Section IV.

As the cavitation erosion progressed on the surface of the AISI 1020, material could not withstand the impacts and started degradation which was notable even after the first hour of treatment (Figure 6(j)). Erosion originated from the cracks, and cleavage of large metal chunks about 50  $\mu\text{m}$  (Figure 6(j), white arrow) was also observed. The collapse of bubbles within those cracks in

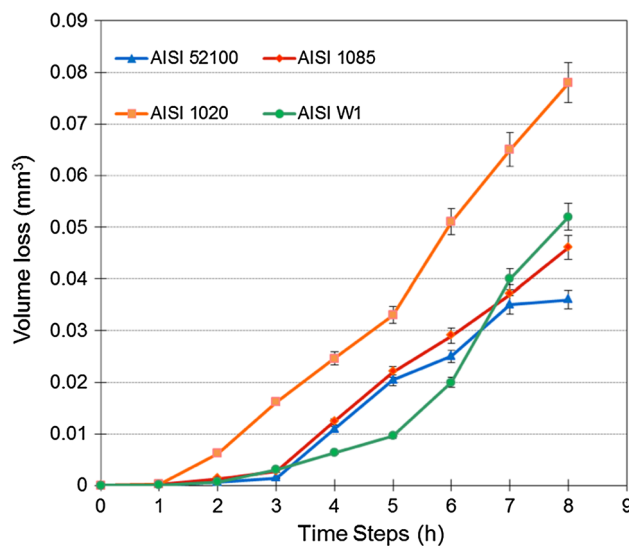
Fig. 7—Cumulative volume loss as a function of time for the examined materials under cavitation erosion.

The cavitation tests were carried out until a clear tendency had been established as explained in Section II-C. The relative resistance of a material to the cavitation erosion can be characterized through measuring the volume loss. The volume loss measured at different times under cavitation erosion is plotted against the treatment time in Figure 7. In general, there was negligible loss of the volume (mass) for all the studied steel grades during the incubation period of cavitation erosion. Volume loss commenced almost immediately after 1 hour exposure to cavitation in all the tests and subsequently increased at a nearly constant rate. It became obvious that AISI 52100 reached the declining period first as the slope curve started to reduce after 7 hours of exposure to cavitation. On the whole, the volume loss in AISI 52100 at the end of the tests was the lowest, approximately 52 pct less as compared with AISI 1020 and 28 pct with AISI W1, indicating the lowest maximum erosion rate among the tested steel grades.

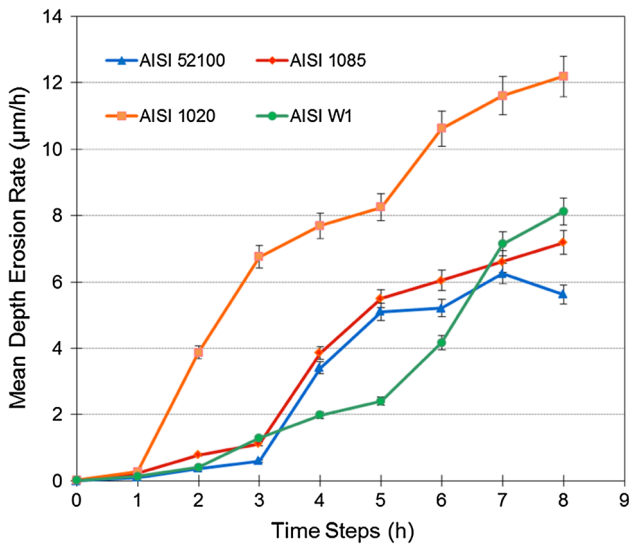
Fig. 8—Variation of the MDER parameter with the exposure time for different steel materials.

The variation of the MDER parameter with the exposure time is presented in Figure 8. It can be seen that in the first hour, the erosion rate increased very slowly for all the test samples, which is a typical feature of the incubation period. At this stage, due to the accumulated internal stresses across the surface layers, plastic deformation initiated and the material surface started to deform (work hardening). Thus, negligible

material loss was observed, although fatigue process could already occur during this period.<sup>[45]</sup> Following this incubation period, the erosion process accelerated. For AISI 1020, the erosion rate started to increase after the first 1 hour of the test and continued until the end of 3 hours where a small attenuation was observed accompanied by a further increment after the end of 5 hours test. There is no evidence of reducing the MDER even after the end of the maximum run test at 8 hours. Thus, the 1 hour of exposure can be considered as the critical point after which AISI 1020 steel significantly decreases its strength and losses its durability. Conversely, for the other tested steel grades the erosion rate gradually increased during the first 3 hours whereupon the acceleration of erosion was observed. This behavior showed that the material was plastically deformed apparently exceeding its fatigue strength limit, which resulted in sudden fast fracture and formation of deep craters.<sup>[46]</sup> In these stages, evolution of microcracks to macrocracks occurred, and large material removal was observed (see Figure 6). After the end of the acceleration stage, a local equilibrium between the erosive power of the cavitation field and the response of the material was achieved. The erosion process stabilised after 7 hours of exposure, indicating the steady period (change in slope) where the rate of mass loss reached the quasi-constant condition. However, this is the case only for AISI 52100, whereas the other steel grades exhibited an incremental rise in the erosion rate. The endurance of AISI W1 steel after 5 hours was considerably reduced, and the erosion rate steeply increased. Hence, over a prolonged period of exposure to cavitation impacts, the AISI W1 steel plate faced inevitable severe damage. Overall, the erosion rate of the AISI 52100 steel was measured to be the lowest among the samples, while its resistance was calculated to be the highest.

achieved by AISI W1 as can be seen from Figure 8. Then, roughness seemed to drastically increase after 5 hours reaching a  $R_a$  value of more than 15  $\mu\text{m}$ .

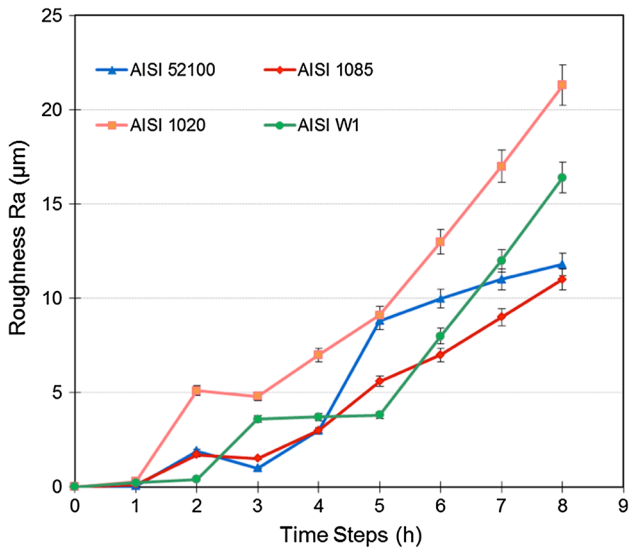
Fig. 9—Results of the surface roughness measurements showing the variation of  $R_a$  with the exposure time of the different steel grades.

Figure 9 presents the evolution of the roughness profile distribution by means of the  $R_a$  parameter. Changes in the surface morphology can be clearly observed after the incubation time. The longer the testing time progressed, the higher the number of undulations that were observed across the surface of the steel samples. As the testing time progressed, the undulations widened and deepened. When the steady state was reached, the new roughness might affect the cavity dynamics, and entrapped gas and liquid in the deep craters started cushioning the bubble collapse, consequently restricting further damage.<sup>[47]</sup>

The shapes of roughness profiles were similar with the exception of the AISI W1 steel (Figure 9) where the restriction of extensive surface undulations and damage patterns (Table III) during the early stages of the erosion delayed the progression of roughness. At the beginning of the erosion process, the roughness profile for the AISI 1020 significantly increased, keeping a linear trend during the following hours and reaching a value of more than 20  $\mu\text{m}$ . In this final stage, erosion could be considered very severe with large craters dominating the damaged surface (Figure 6(l)). The AISI 52100 and AISI 1085 steel samples had a similar roughness profile evolution showing a much smoother growth of their  $R_a$  values with time. Within the first 3

hours, AISI W1 steel exhibited an RA increment of about 4  $\mu\text{m}$ . Then a quasi-steady period followed between the 3 and 5 hours steps. The lowest erosion rate among the tested steel grades during that stage was

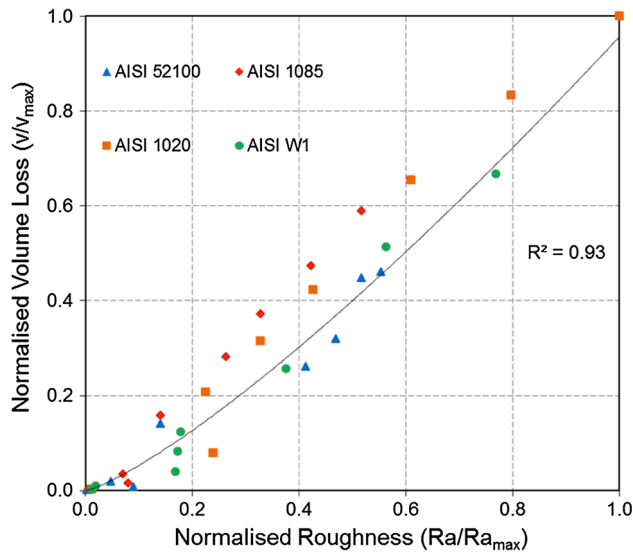
Fig. 10—Curves of the normalized volume loss vs normalized  $Ra$  roughness parameter.

The normalized data (Figure 10) for both of the quantities illustrates a very good fit among the different steel samples that can be expressed with Eq. [6], where  $a$  is 0.96 and  $n$  is 1.25. Note that specific tests cover different ranges of the erosion curve, but all test data fall on one common erosion curve with a satisfactory cross correlation factor  $R^2 = 0.93$ . These results are in agreement with<sup>[48,49]</sup> showing that the roughness of the eroded surface is related with the mass detachment process under cavitation erosion conditions.

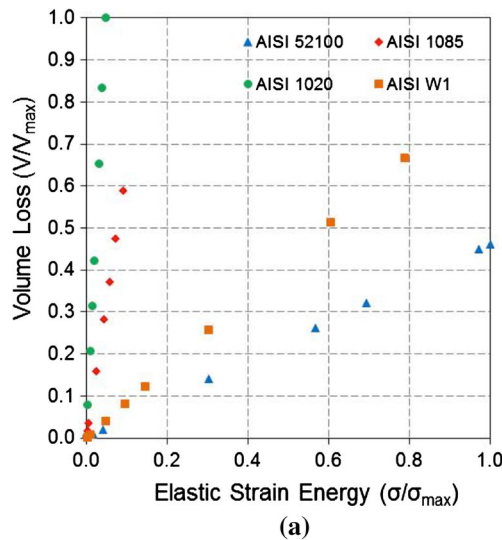
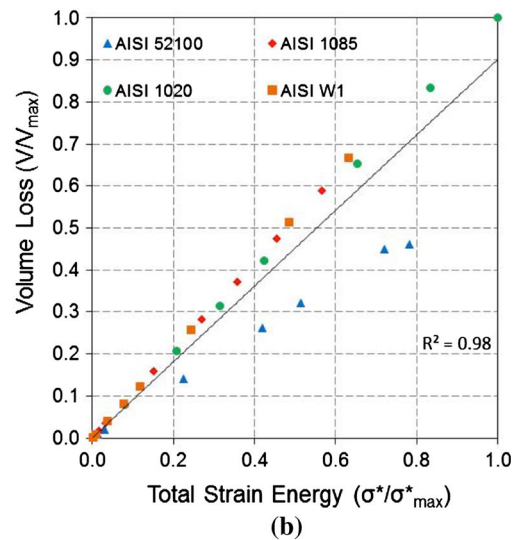
Fig. 11—General behavior of the tested steel grades is shown by the normalization of (a) elastic accumulated strain energy  $E_{el}$  and (b) total accumulated strain energy  $E_{tot}$  with the variation of the volume loss. All curves start from the origin, but for the same physical time, the tested materials reached different erosion stages (each point represents an hour time step up to 8 h).

Figure 11 presents data normalized to the maximum value of the accumulated strain energy with the volume loss according to Eqs. [3] and [4] with the data taken from Table II and Figure 8 in the case of brittle behavior (Figure 11(a)) and in the case of elastoplastic behavior (Figure 11(b)). The AISI 52100 steel exhibits

the best cavitation erosion performance among the tested steel samples, *i.e.*, for the same time exposure to cavitation damage (*i.e.*, 8 hours) much more accumulated strain energy is required in order to remove the same amount of material.

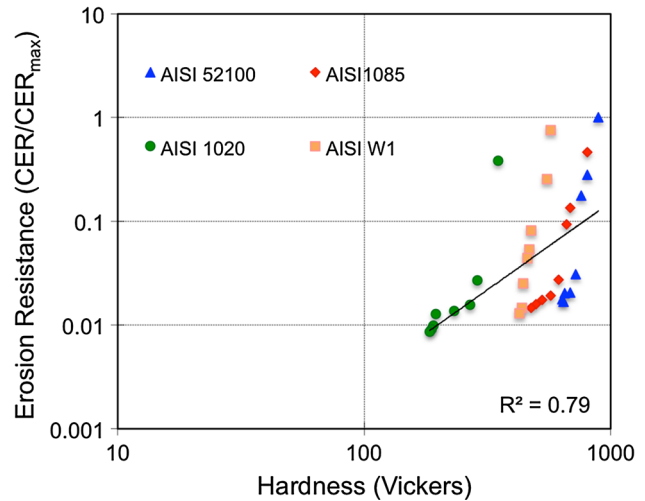
Fig. 12—Correlation of hardness to the cavitation erosion resistance for the studied steel grades (normalization curves).

In Table IV and Figure 12, the cavitation erosion resistance (CER) was evaluated in terms of hardness. It can be noticed that the drop of hardness after the end of cavitation incubation stage was very rapid for every material (compare initial hardness in Table II and measurements in Table IV). For the AISI 52100 and W1 steel grades, work hardening occurred during the first hour of cavitation erosion. Hardness increased by 2.5 and 5.5 pct for AISI 52100 and W1, respectively. There is a possibility (based on previous observations in References 31) that the changes in microstructure of the both steel grades resulted in the increased surface hardness due to martensite deformation within the martensitic laths, and then in the hardness decreased as a result of fatigue crack initiation and propagation, local fracture, and subsequent crater formation. In contrast, for the remaining two steel grades the hardness dropped to about 8.5 pct for the AISI 1085 and 15 pct for the AISI 1020 during the same period of time. AISI 1020 with the lowest carbon percentage was incapable of resisting severe impacts from the implosion of the cavitation bubbles as the material lost stability and experienced accelerated damage. Hardness reduction of AISI 52100 and AISI W1 steel grades during the testing period of 8 hours reached 26 and 21 pct, respectively, while for AISI 1085 and 1020 steel grades it reached 46 and 51 pct, correspondingly. These data clearly highlight

the counterbalancing effect of the work hardening component in the evaluation of durability of the material against cavitation and the attenuation of the micro-durability of the material as also shown by Krella.<sup>[53]</sup> The overall behavior of the erosion resistance can be expressed as a function of the hardness *H* as per Eq. [8] where *a* is 0.9 and *n* is 7.8 ( $R^2 = 0.79$ ) (Figure 12):
