# Testing Fibre Stabilisation for Earthquake Resilience of Earth Mortar in Stone Masonry Construction

## ABSTRACT

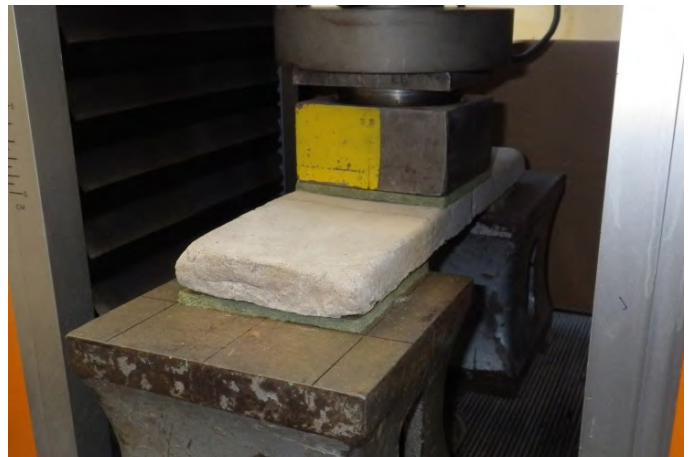
The aim of these tests was to determine the shear resistance of mortar samples with and without reinforcement. The tests were undertaken in the Lloyd compression testing machine on 350mm x 100mm x 25mm (approx.) samples supported on 100mm square steel blocks, such that the samples spanned approximately 150 mm between supports. The load was applied at a steady displacement rate at mid-span through a 100mm x 100mm steel bearing. The aim was to produce shear failure in the samples, although in practice failure was likely to be a combination of shear and bending (due to the geometry of the samples). The test set-up is shown in Figure 1.

Figure 1. Test set-up  
Figure 1. Photograph of testing apparatus:  
Source Oxford Brookes University Laboratory

The aim of the first test was to determine the load and associated deflection at which the mortar failed in shear through cracking. This corresponds to the point at which the mortar joint may no longer be serviceable in the long term, but retains sufficient integrity to prevent collapse of the wall. During this test, the displacement of the bearing relative to the supports was increased at a steady rate (0.25 mm/min) until a reduction in load was observed. In the case of the unreinforced control samples, collapse of the test specimen occurred at this point.

The aim of the second test was to determine the degree of structural integrity provided by the reinforcement after the initial failure of the mortar. Following completion of the initial test, each sample was removed from the testing machine,

inspected and photographed and then reinstalled into the machine. Load was applied for a second time until total failure was observed, at which point the load reduced rapidly to zero and the sample broke into two pieces. In some cases, where the quantity of fibres was sufficient to prevent separation of the two halves of the sample, the test was terminated at a maximum displacement of 10 mm.

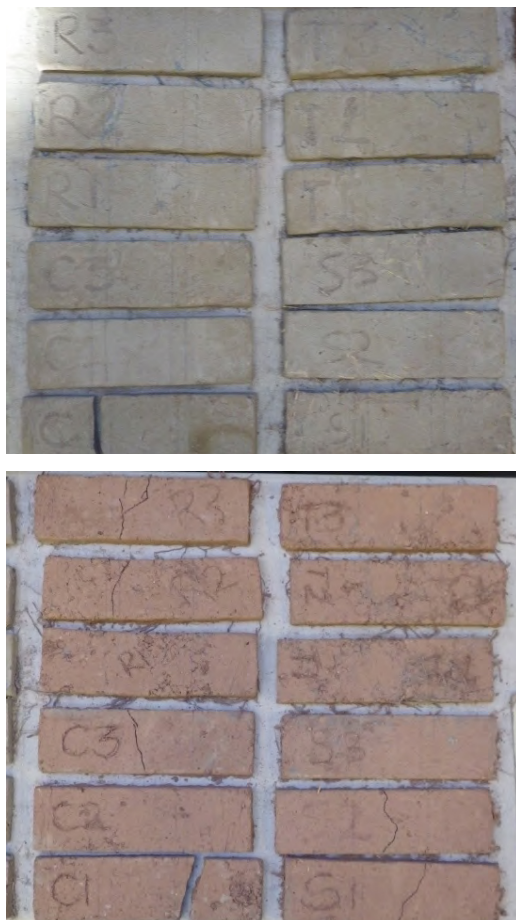
Prior to testing, the samples were inspected for damage and photographed. The initial condition of the test specimens is shown in Figure 2.

Figure 2. Photograph of Initial condition of samples prior to testing. Source Oxford Brookes University Laboratory

It is apparent that the earth mortar specimens were in noticeably worse condition than the normal mortar.

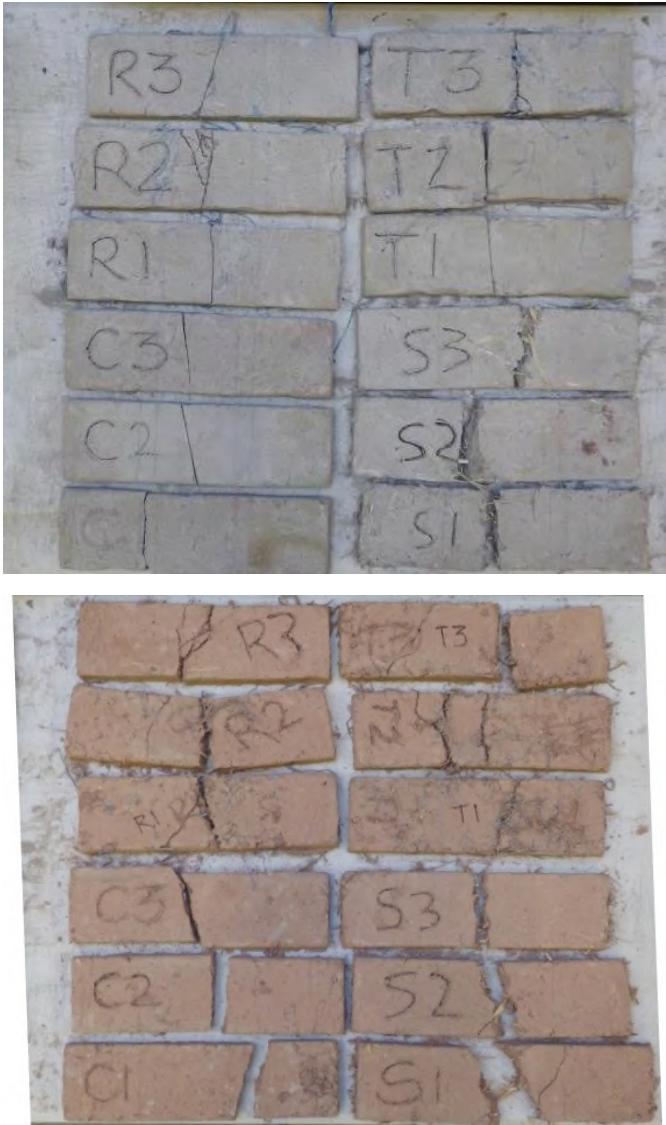
After completion of the test programme, the samples were photographed for a second time. The final condition of the test specimens is shown in Figure 3.

Figure 3. Photograph of final condition of test samples Source Oxford Brookes University Laboratory

In most of the cases, the load increased to a maximum before falling to zero, at which point the remaining fibres either failed in tension or pulled out of the mortar. In a few cases, however, the test was stopped automatically at a pre-set displacement limit of 10mm before the load had reached zero. In one case, the load continued to increase until the test was stopped automatically at an applied force of 300N (plus the bearing weight of 52N). It was noted that the key factor that determined whether the samples broke in two or remained intact to 10mm displacement was the density of fibres in the central region of the sample. Samples with sparse fibres or those with fibres only on the top or bottom surface of the sample did not perform as well as those with many fibres located at mid-depth. The type of reinforcement and even the type of mortar had little impact on the performance of the samples.

A programme of shear tests has been undertaken on mortar samples with and without reinforcement. Significant variability in the initial resistance (when the samples first cracked) and ultimate failure was observed, but there was no clear distinction between the three types of reinforcement and two types of mortar. The performance of the samples between initial cracking and ultimate failure was largely dependent on the density of the reinforcement fibres and their location rather than the type of fibre or mortar. Samples with sparse fibres or those with fibres only on the top or bottom surface of the

sample did not perform as well as those with many fibres located at mid-depth.
