SHELTER PROJECTS

2015-2016

CASE STUDIES OF HUMANITARIAN SHELTER AND SETTLEMENT RESPONSES

Published in April 2017 by the International Organization for Migration (IOM), on behalf of the Global Shelter Cluster

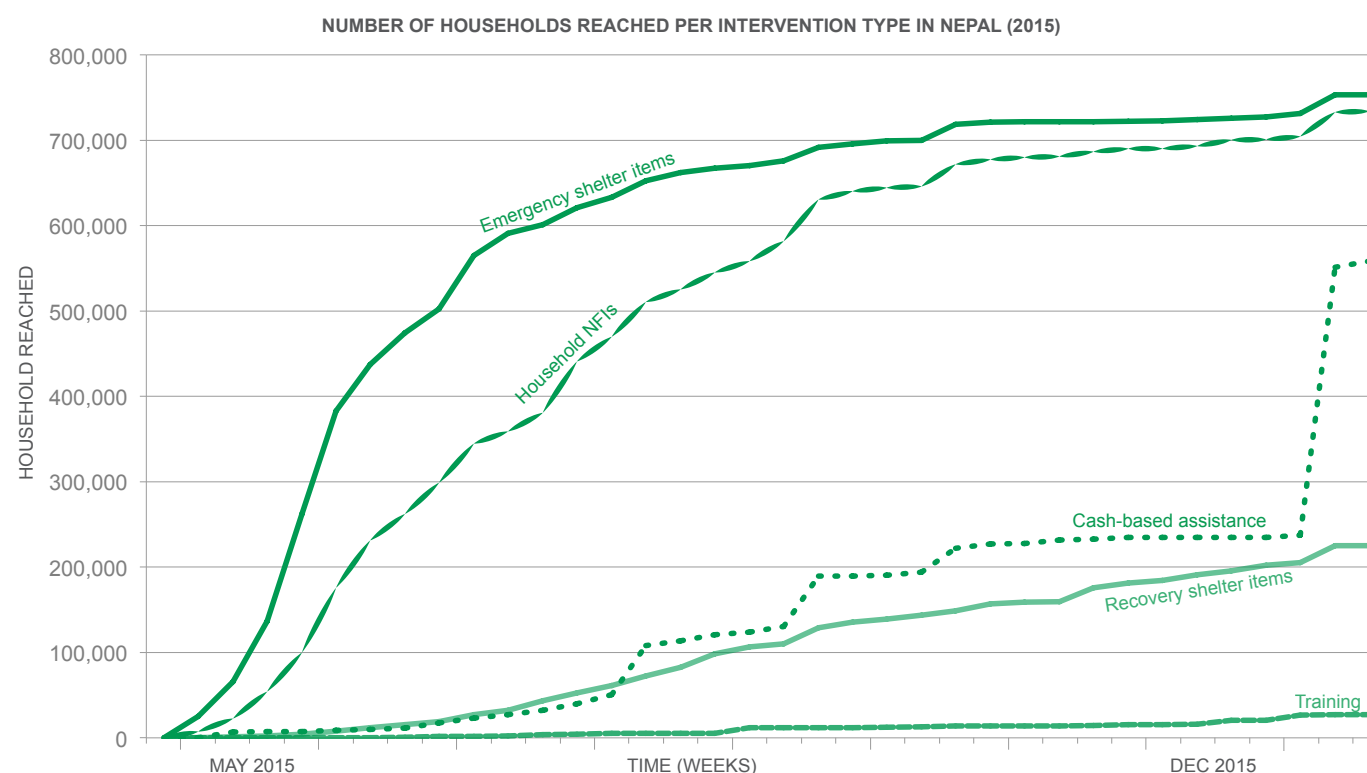
Figure 4. This chart shows the cumulative number of households reached with the main modalities of assistance in response to the Nepal earthquakes (Source: Shelter Cluster Nepal). It can be observed how emergency shelter items and NFIs were distributed in significantly larger scale and sooner in the response, while recovery shelter items, training and cash took longer to be implemented, and with lower totals. Notably, cash-based assistance had a peak approximately eight months after the disaster.

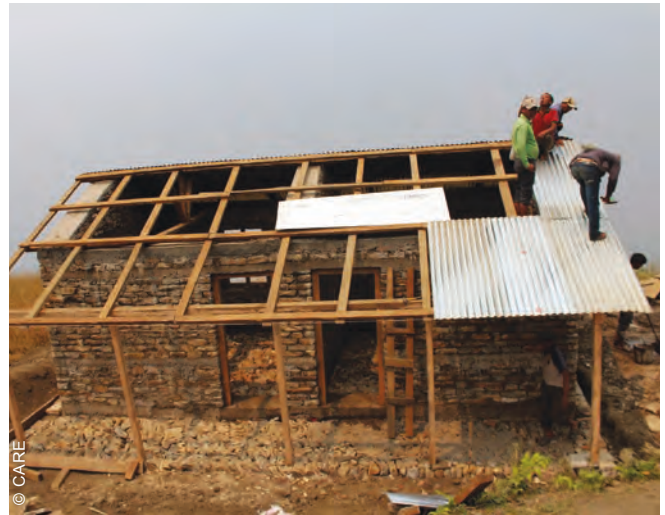
Houses were repaired also using the materials provided by humanitarian organizations, such as CGI sheets and timber.

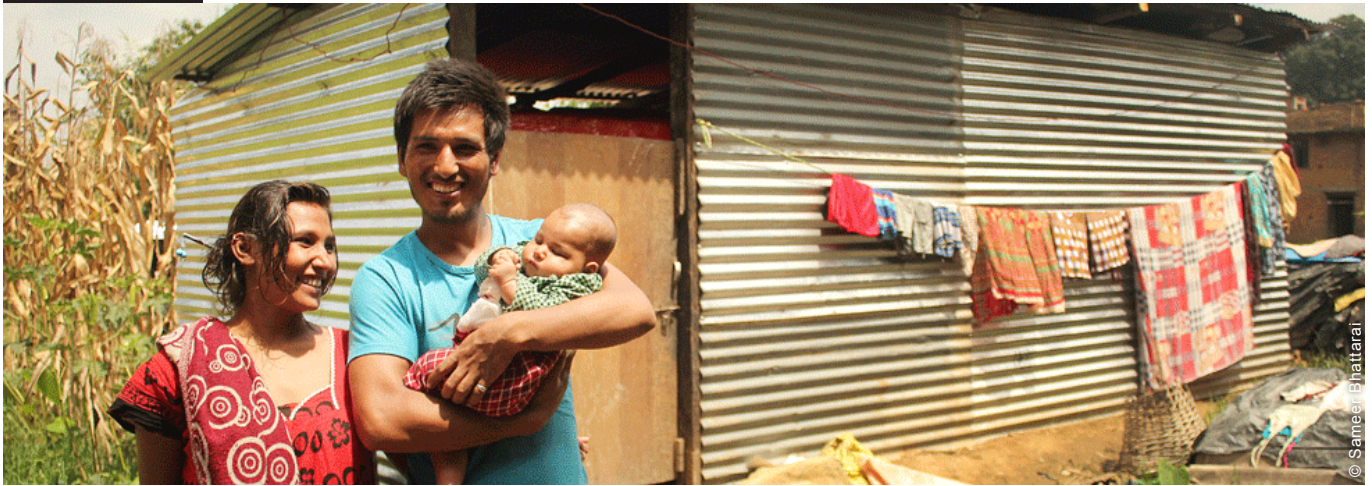
Although a set design was provided by the organization, many people adopted their own designs, using the materials provided with the kits, along with salvaged materials, to meet their own specific needs

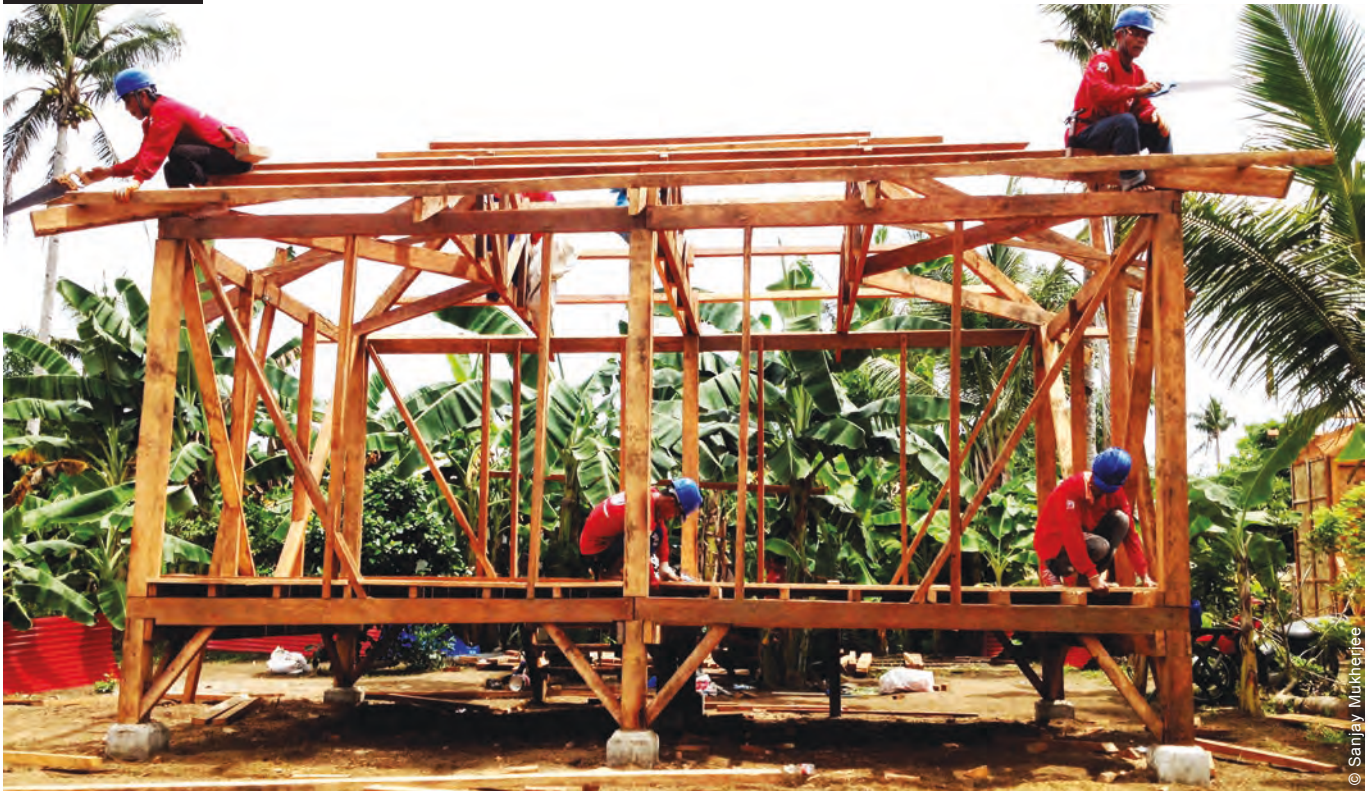
Core shelters were built in several batches by construction teams that included the beneficiaries. Material supply and monitoring were managed by the organization.

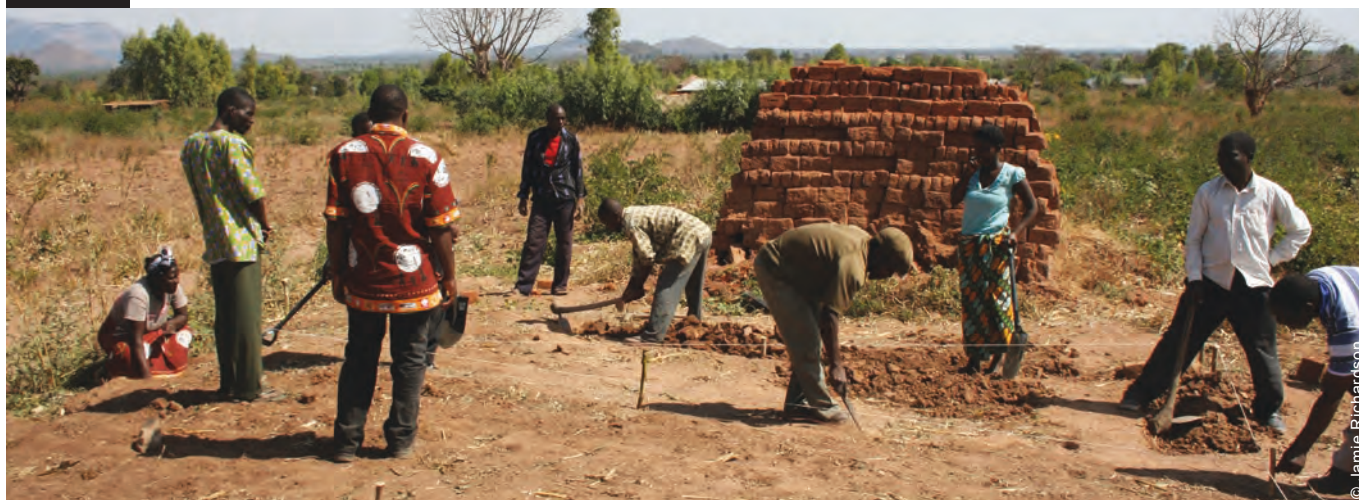
People were given technical trainings and built model houses as part of the project. Here they are working on setting out the foundations of a model house..

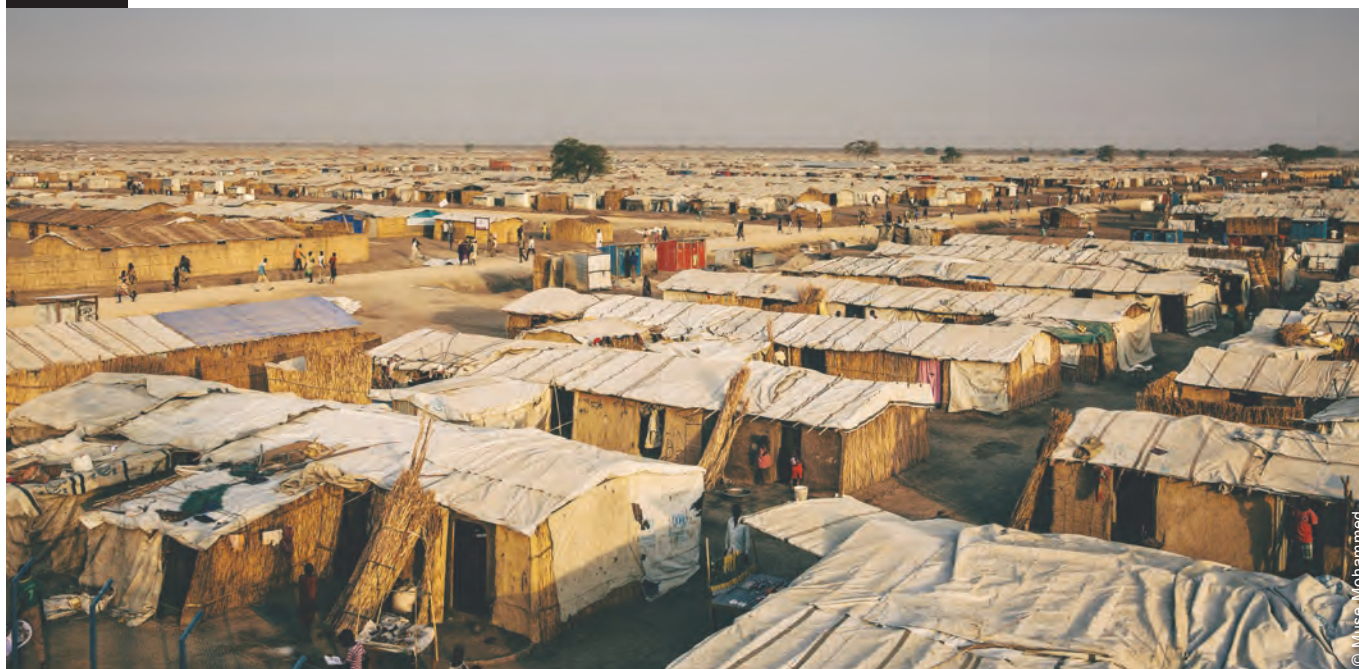
The shelter project built communal shelters due to lack of land and nationally limited resources. These shelters allowed to maximize the use of limited space and impacted shelter strategies throughout the country.

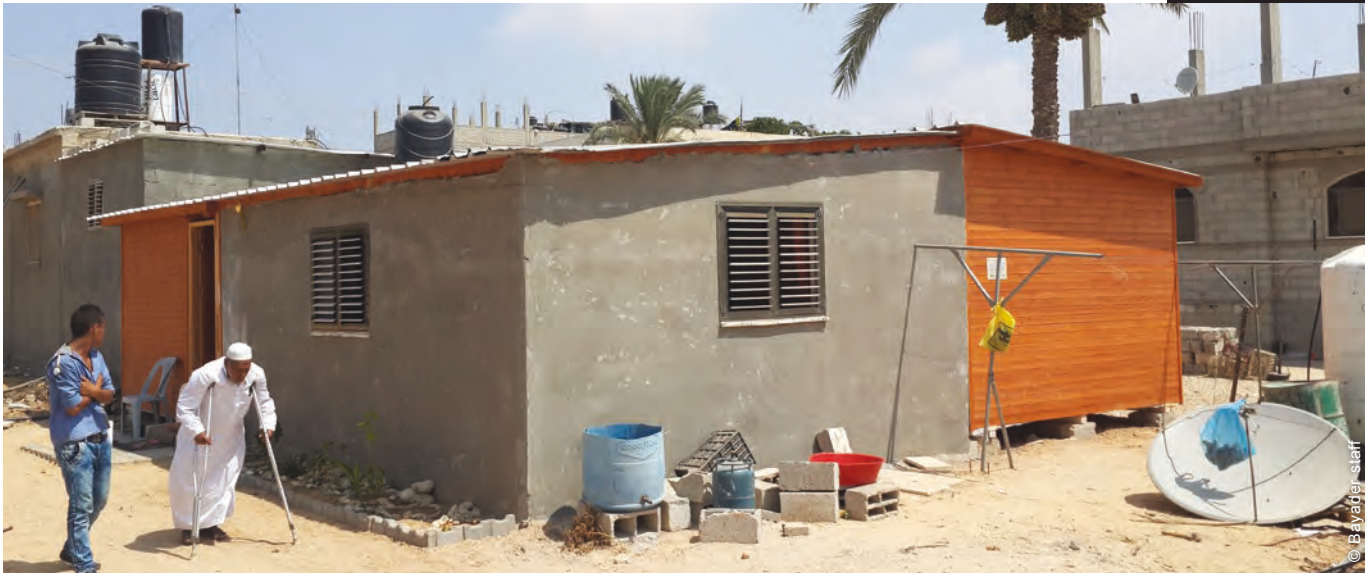
Some people were able to extend the shelters, by closing the open sides of the veranda.

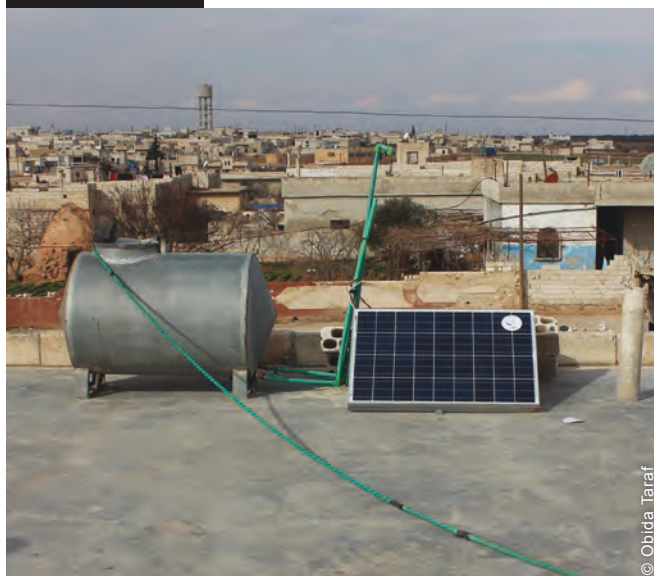
The project included installation of solar panels for selected households.

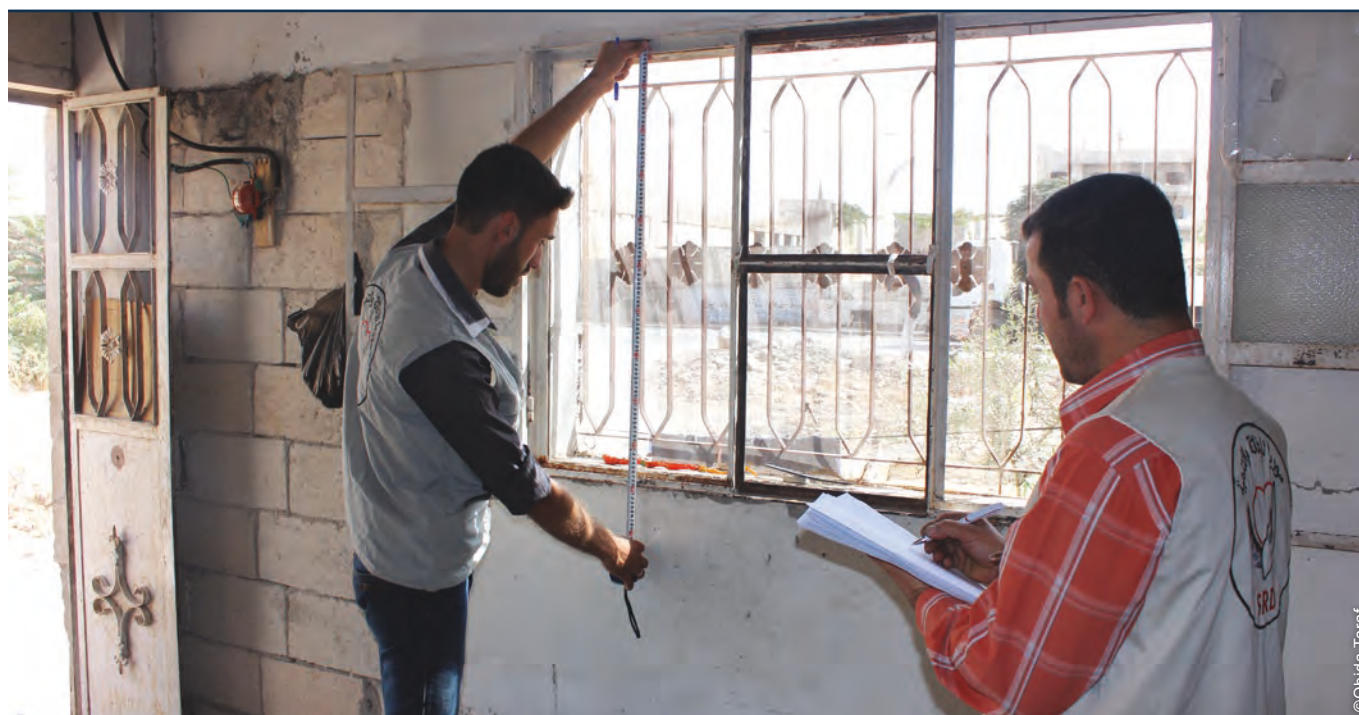
The project included repairs and upgrades to walls, floors, ceilings, doors and windows and installation of wiring, plumbing and latrines.

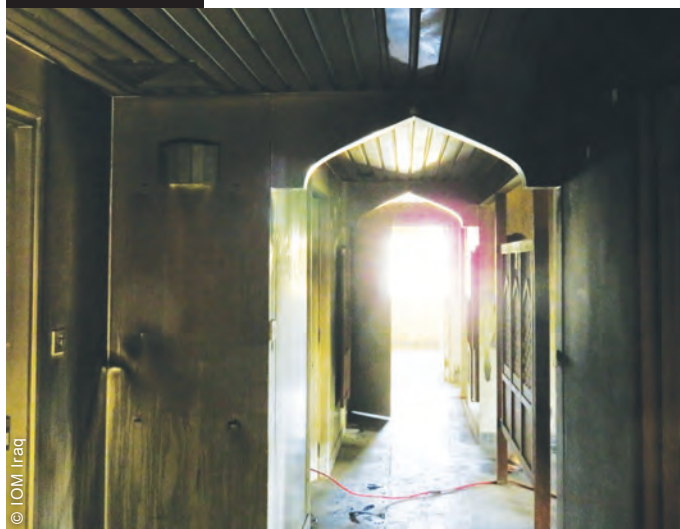
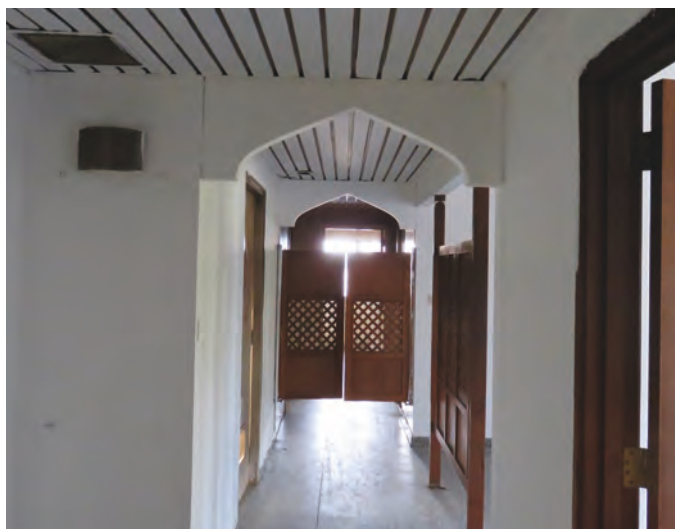
The project repaired damaged homes of returnee families through a variety of works. Here in Salah Al-Din, before (left) and after the upgrades (right).
